## SUPPLEMENTAL FAULT EXPLORATION

OAK KNOLL  
OAKLAND, CALIFORNIA

**June 23, 2015**

**Project No:**  
5750.300.000

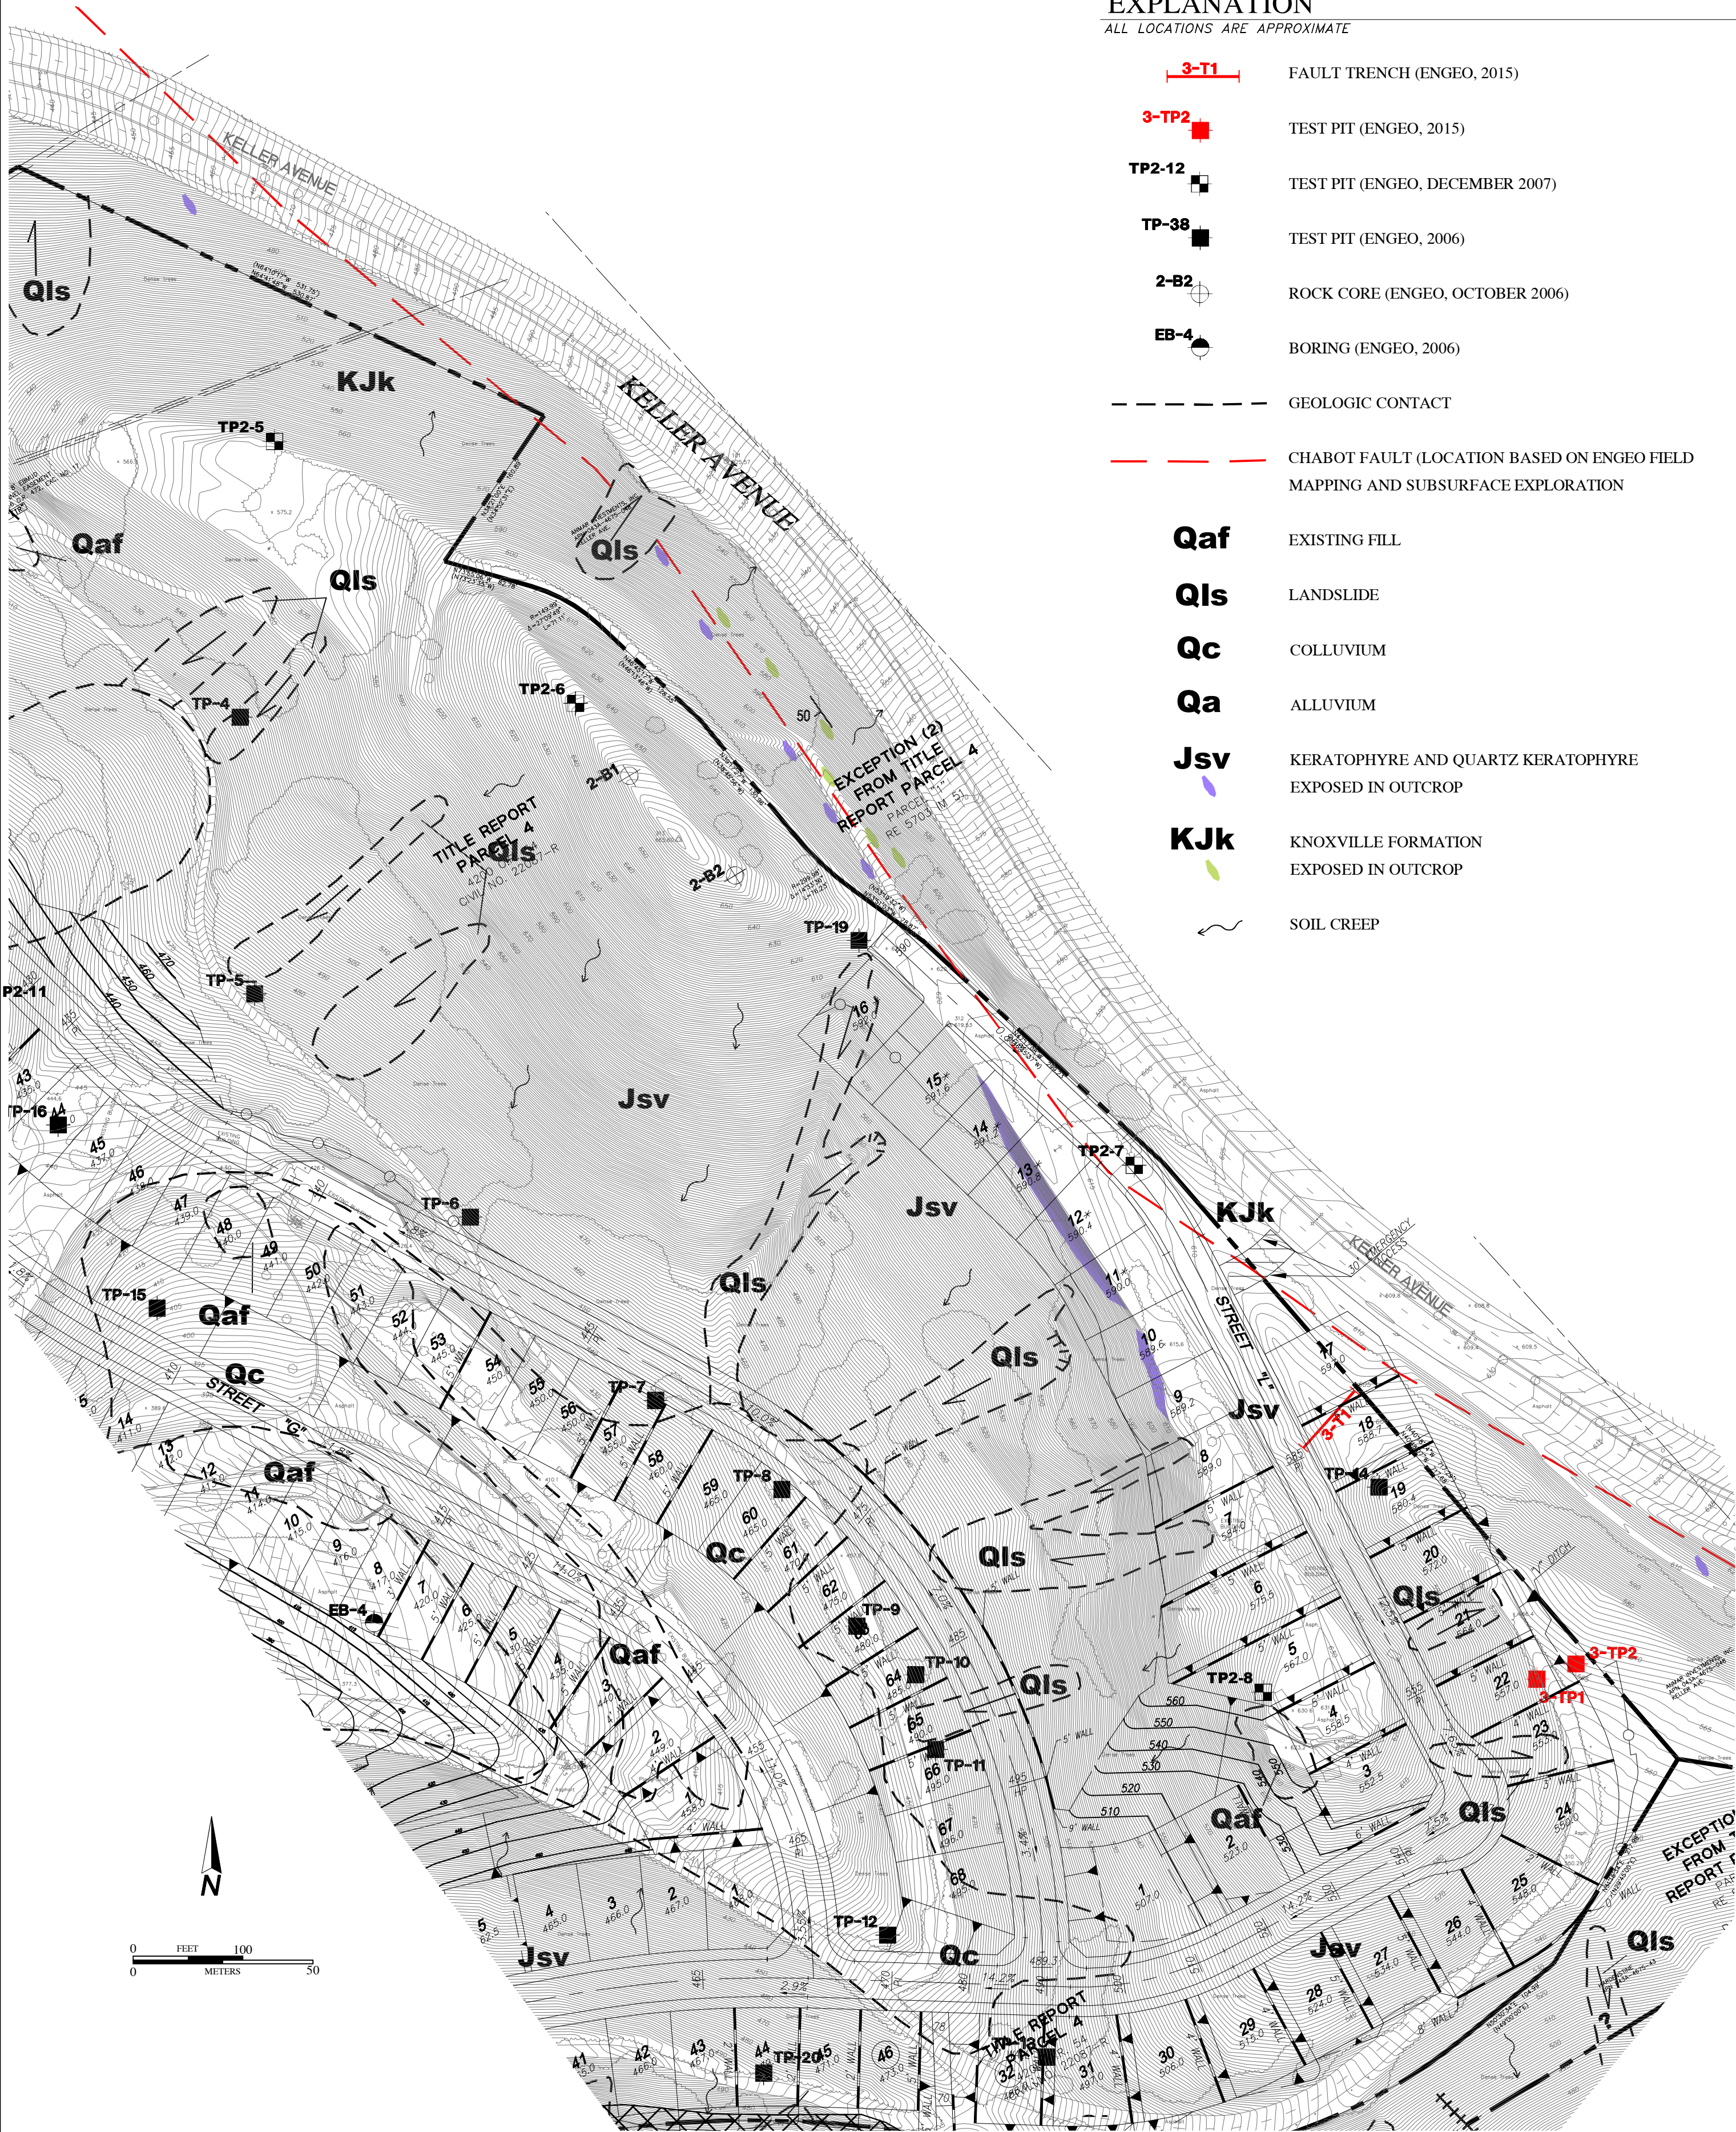
SITE PLAN  
OAK KNOLL  
OAKLAND, CALIFORNIA

A fault zone was not encountered within our trench or test pits excavated at the site. The test pits and trench indicate that the contact between the Jurassic Volcanics and the Knoxville Formation is located east of site boundary at the southeast portion of the site as shown on Figure 2. Mapping along the west side of Keller Avenue further constrain the location of the contact.

Further north Test pit 2-TP7, excavated during our previous exploration at the site, encountered claystone interpreted as Knoxville Formation. Jurassic volcanics were mapped in outcrop roughly 35 feet southwest of this test pit constraining the fault contact to within this 35-foot wide zone at this location as shown on Figure 2.

In our opinion, the fault mapped across the eastern portion of the site is not considered active and may actually represent a depositional contact. In our opinion no setback zone is required. The contact between the Jurassic Volcanics and the Knoxville Formation should be further examined during grading for the project to determine if supplemental corrective grading measures are needed to address potential engineering issues such as weak sheared material or a groundwater barrier.

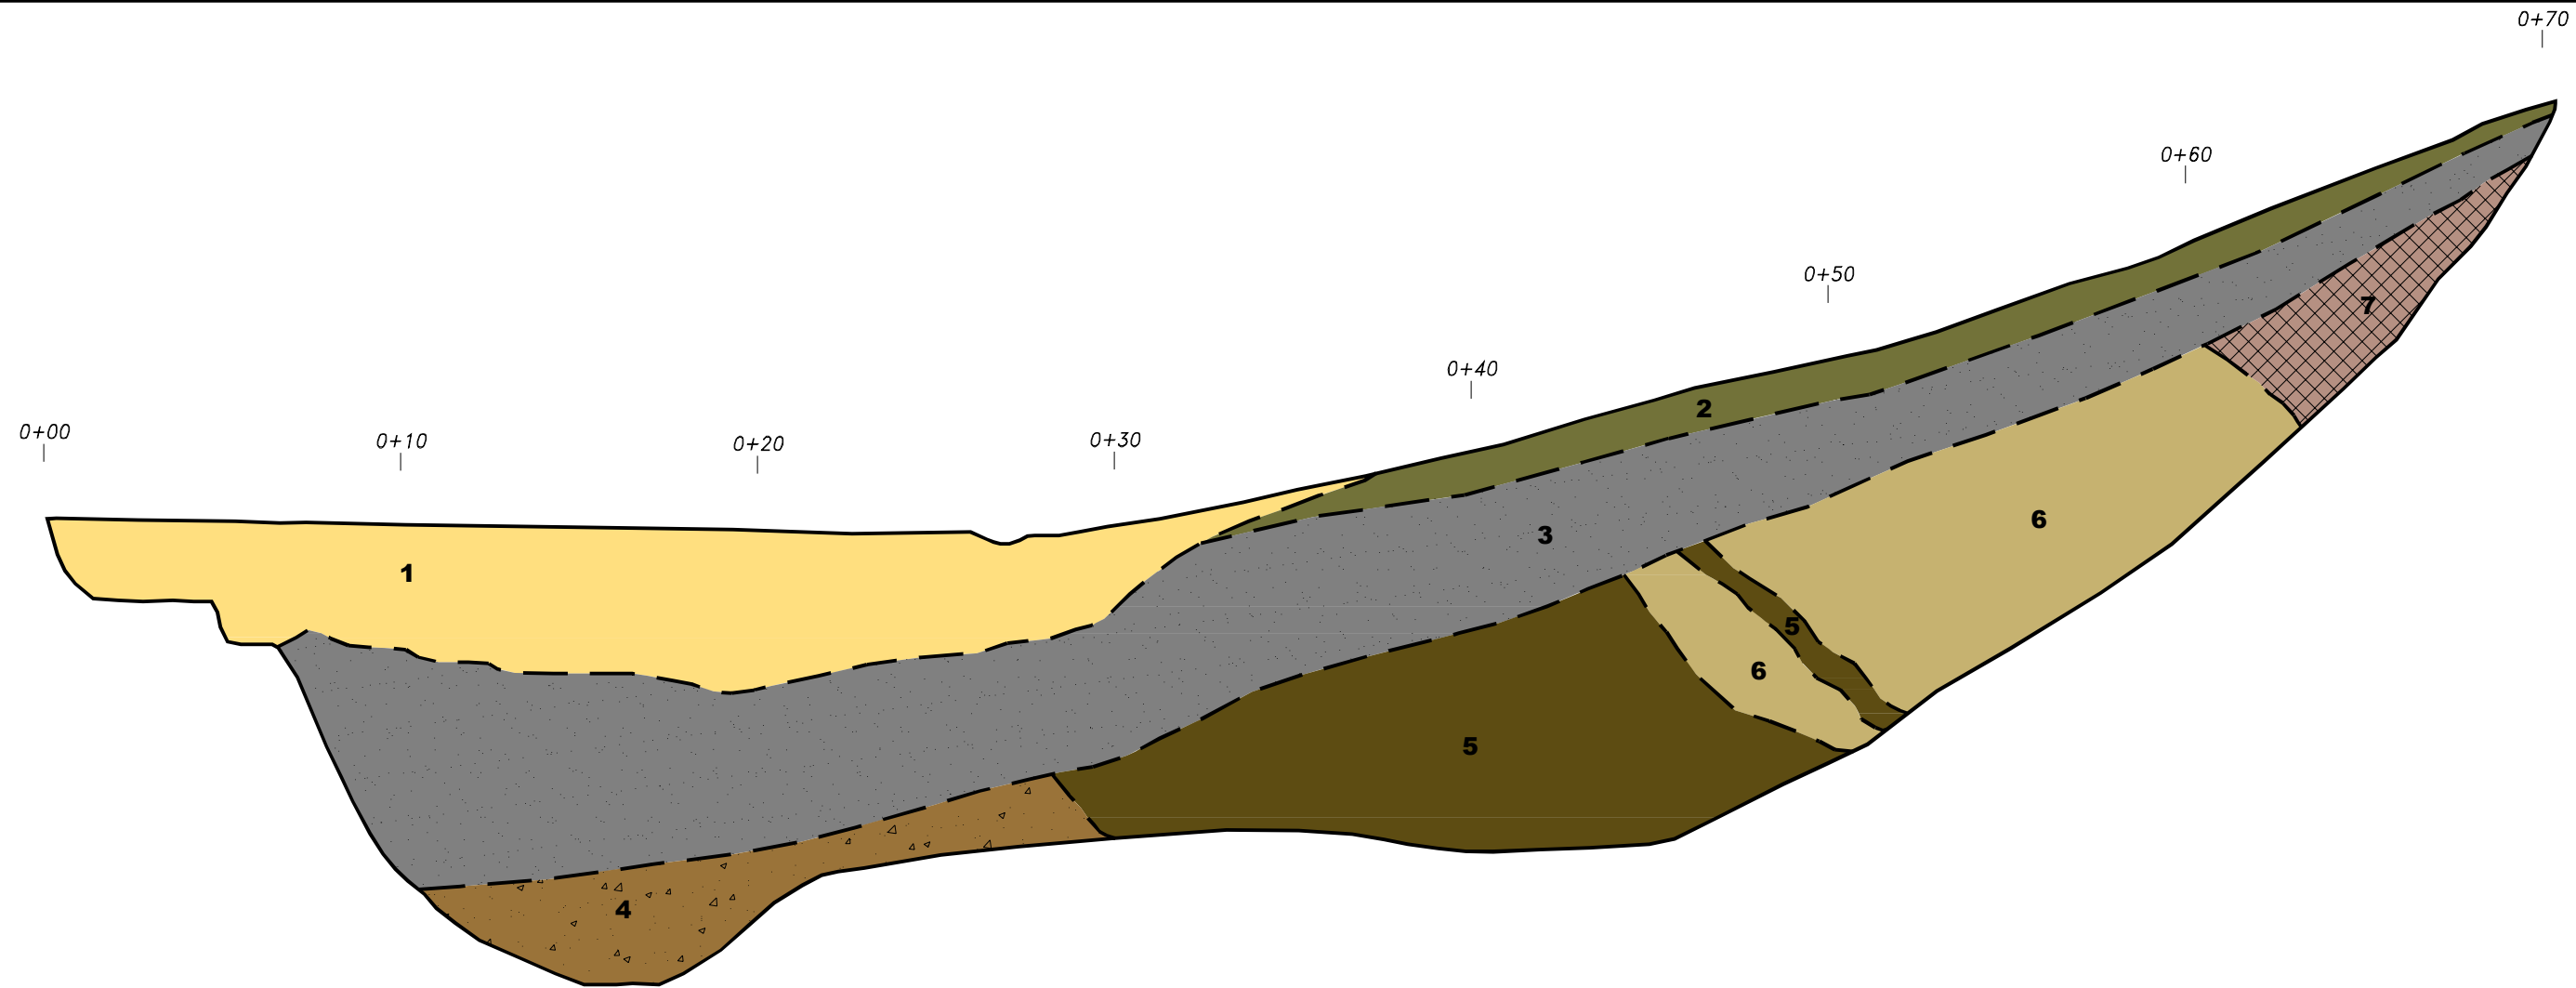
TRENCH LOG - 3-T1  
OAK KNOLL  
OAKLAND, CALIFORNIA

Exploratory Trench 3-T1 encountered approximately 3 to 5 feet of fill from Stations 0+00 to 0+35. The existing fill encountered in the trench appeared to be associated with the grading for the existing roadway along the eastern property boundary. A thin organic rich soil was encountered within the upper 1 to 2 feet from Stations 0+35 to 0+70. Below the upper thin soil and fill a 2 to 7 foot thick layer of colluvium was encountered overlying bedrock. The colluvium thickened from west to east. Bedrock comprising, extremely weathered pale reddish brown volcanoclastic breccia was encountered from Station 0+05 to 0+30. Gray to pale gray brown tuffaceous mudstone was encountered from Stations 0+30 to 0+65. The Tuffaceous mudstone was massive and closely fractured to crushed. Extremely weathered, pale reddish brown, yellowish brown and pale yellow, rhyolitic breccia was encountered from Station 0+62 to the west end of the trench. The attached trench log, Figure 5, depicts conditions that were exposed on the south wall of the trench.

Bedding was not discernible due to the massive and disrupted nature of the rock. A pervasive structural fabric composed of closely spaced fractures was observed striking N80W and dipping 55 to 60 degrees towards the southwest. No clear indication of faulting or fault features was observed in the bedrock or overlying soil profile.
