Memorandum

Date: June 25, 2019
To: File
From: Gabriel Lemus, CDBG Program Manager
Contra Costa County, Department of Conservation and Development
In RE: *Re-evaluation of Veterans Square project under NEPA*

Description of Project Changes

**PHASE I ENVIRONMENTAL SITE ASSESSMENT
OF THE PROPERTY AT
295 EAST 10TH STREET, PITTSBURG, CALIFORNIA**

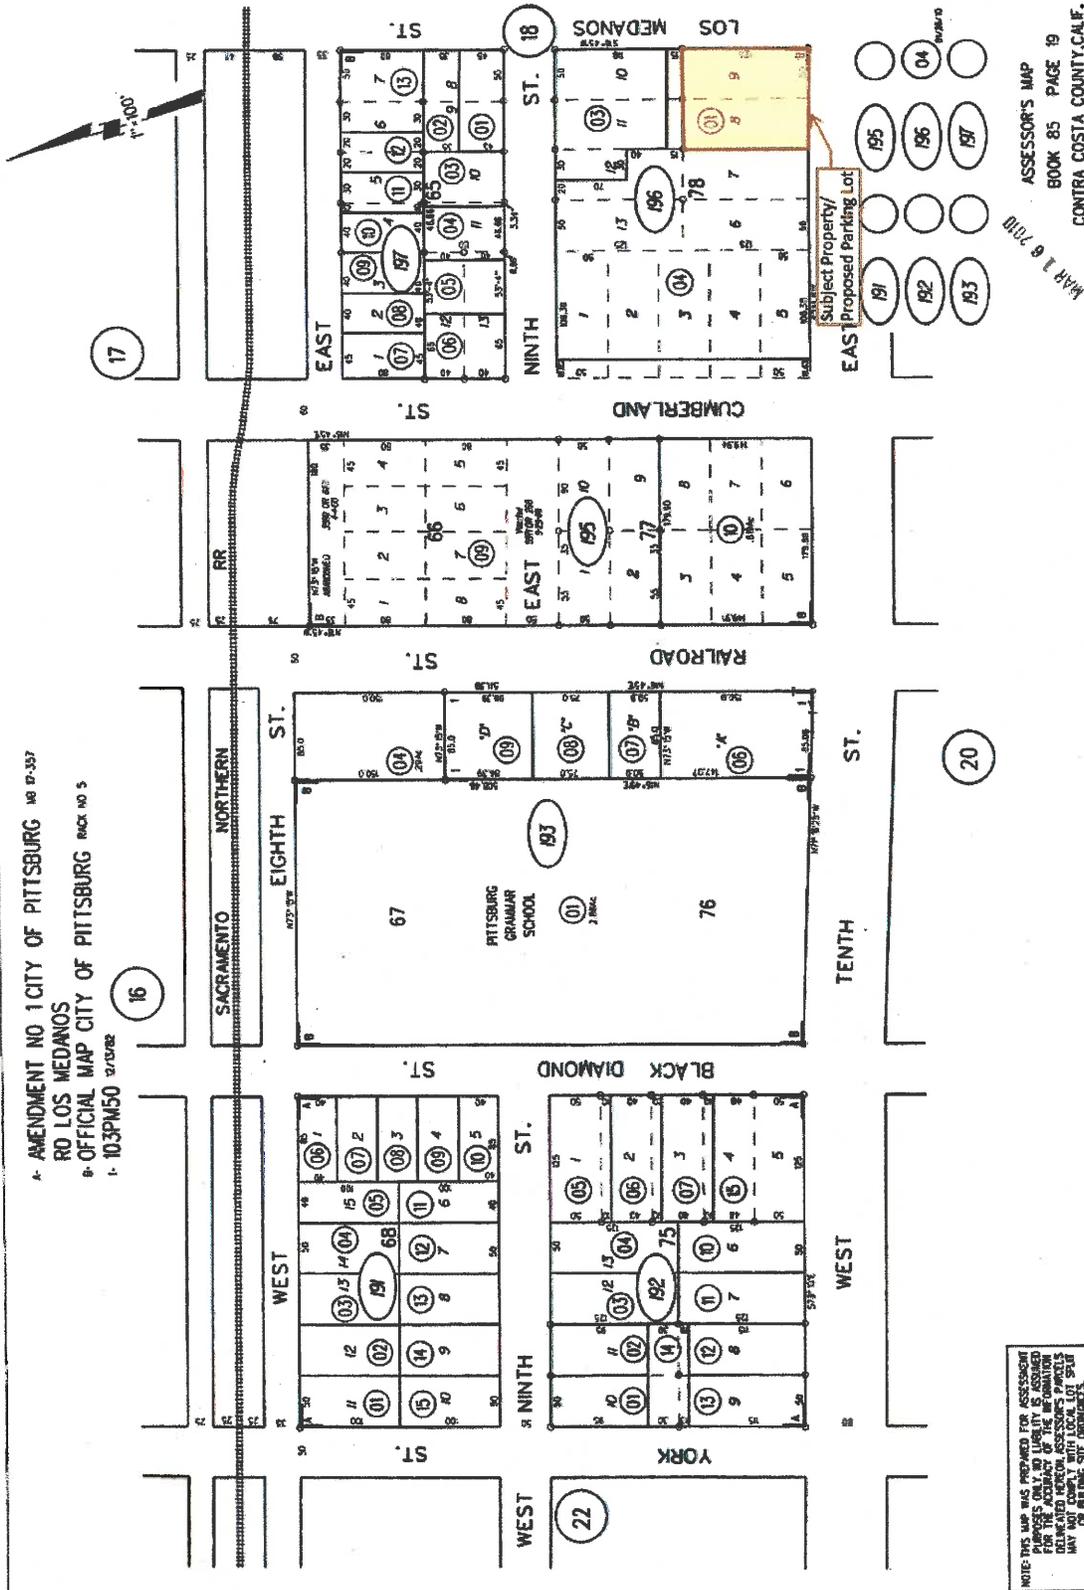
Figure 4 additional parcel for this revised consultation

Site included in original Environmental Assessment

Parking lot added to project

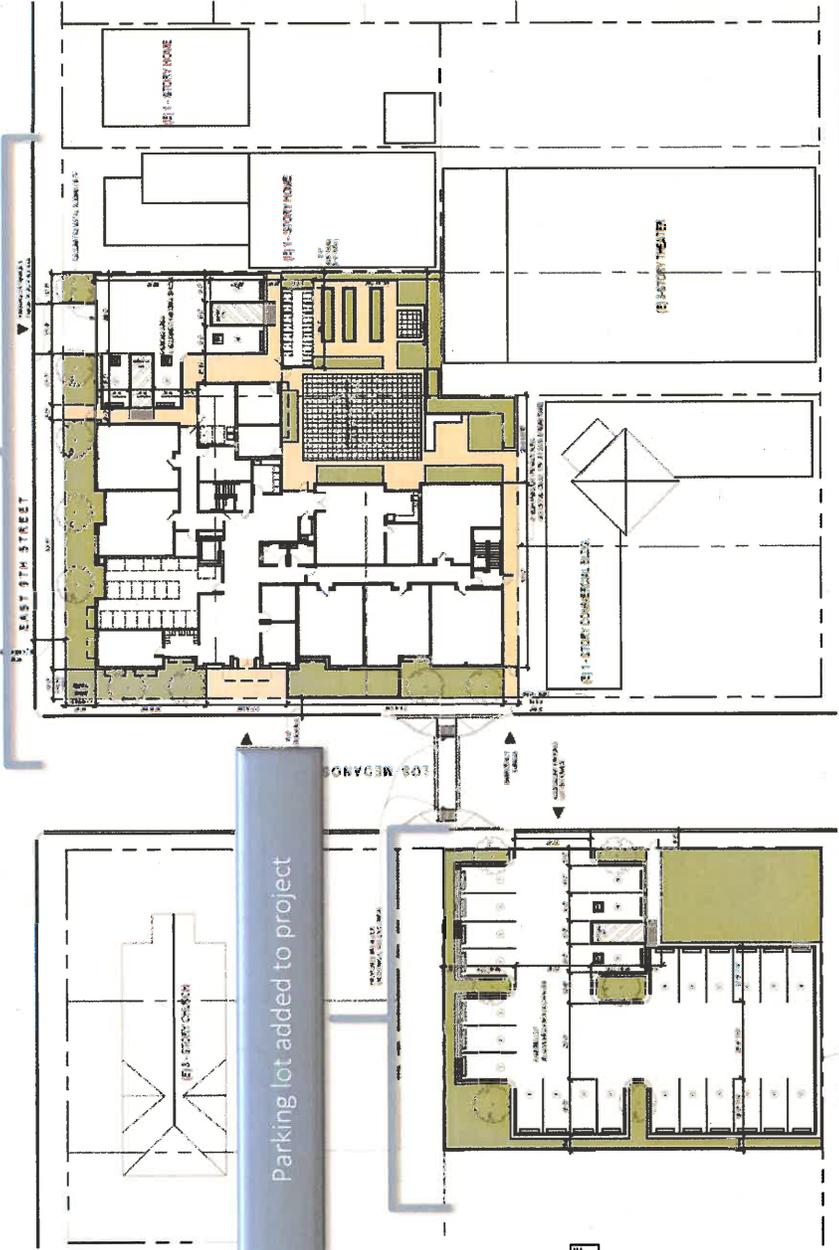
Figure 5 Amended site plan

PROJECT SITE PLAN

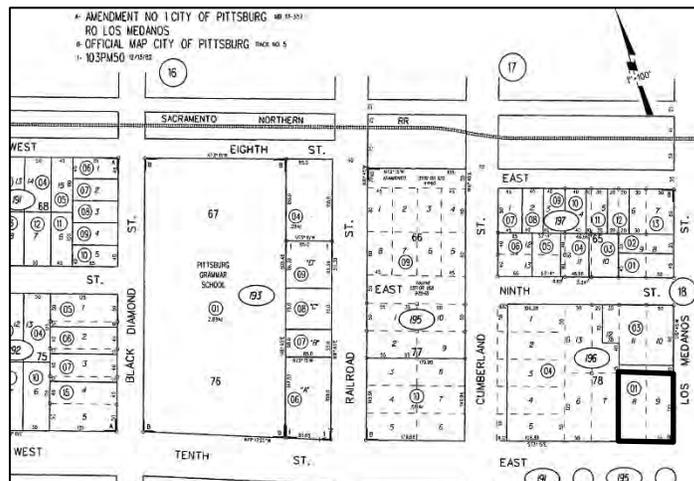
Figure 2.1.1. Assessor’s Parcel Map, with subject property outlined in heavy line.

The subject property (“Property”) of this Phase I ESA is the parcel with address of 295 East 10th Street, Pittsburg, (APN 085-196-001), and is bounded by Los Medanos Street to the east, East 10th Street to the south, a vacant lot to the west, and commercial properties to the east in the City of Pittsburg, Contra Costa County, California (Figure 2.1.1). The Property consists of one parcel with an area of approximately 12,000 square feet, and is vacant, undeveloped land. The Contra Costa County Assessor’s office assigns this parcel land use code 79 with the description of “City of Pittsburg Lots 8 & Block 78”.

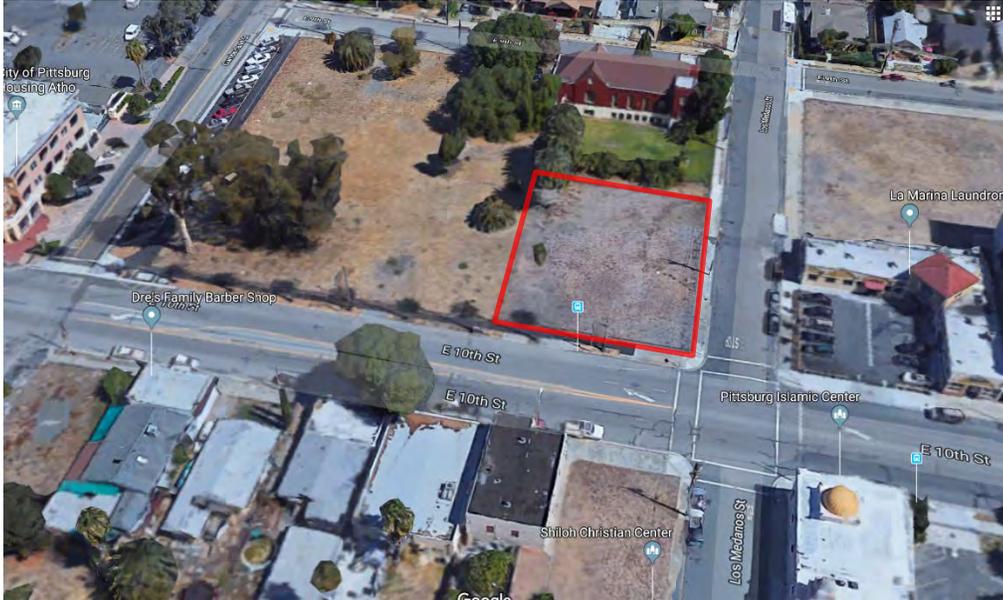
Figure 2.3.1. Oblique aerial photo, view looking north, of subject property (outlined in red) and surrounding properties (Google Maps).

The Property is approximately 12,000-square feet of vacant, undeveloped land. Improvements consist of chain link fencing surrounding the entirety of the parcel boundary. A driveway and gated entry are present along the middle portion of the eastern parcel boundary. The Property appears unmaintained, with overgrown vegetation, areas of accumulated rubbish, several large piles of plant material and woodchips, and two small areas containing crushed asphalt and gravel. One overhead power pole is present on the sidewalk easterly adjacent to the Property. Overhead electrical service is provided by PG&E.

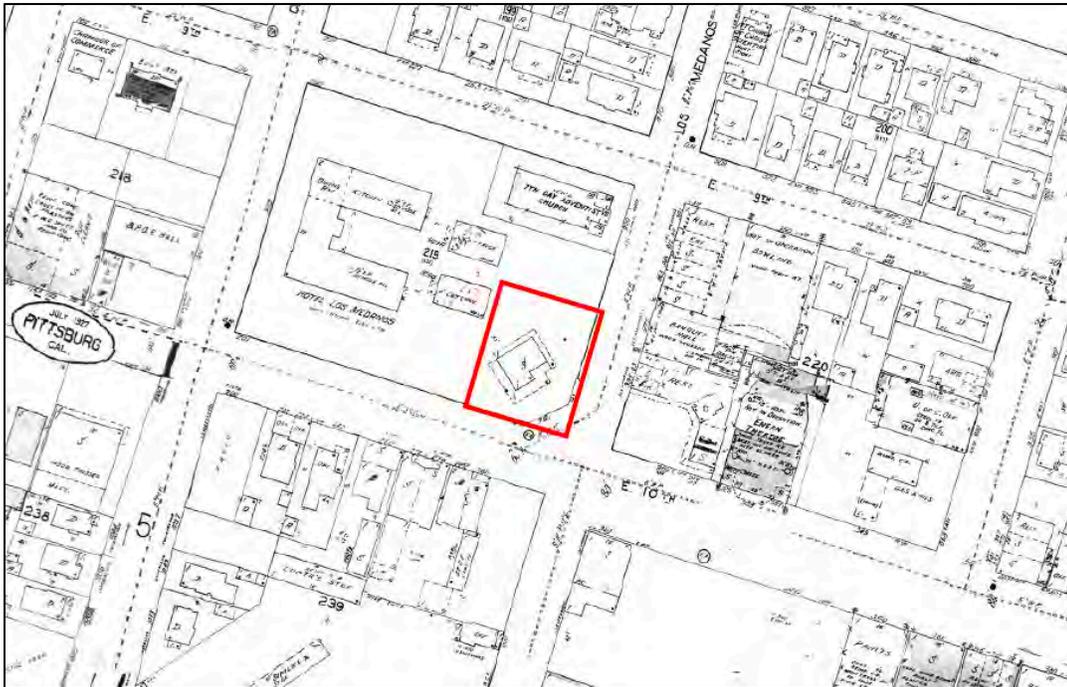
Figure 4.4.3. Detail of Sanborn Co. Fire Insurance Map dated 1966 from EDR

Fire insurance maps are historical city and building layout maps produced for private fire insurance companies (primarily by the former Sanborn Company). These historical city maps can indicate the presence of structures on, or uses of, properties at specified dates. EDR purchased the Sanborn Company, and provides any available fire insurance maps for the target address. EDR's Sanborn report provided maps with coverage of the Property by Sanborn Maps (see Appendix 14.3 for the map excerpts). The 1917, 1927, and 1949 maps do no record any structures on the Property, however a hotel is present westerly adjacent and some single family residences in the surrounding area. The area occupied by the hotel in these maps is currently a vacant lot. The current church, northerly adjacent, is present by 1927 in the configuration in which it exists today. The 1958 and 1966 maps show the development of the Property with a single-story store (commercial building) (Figure 4.4.3). No indications of any possible recognized environmental conditions were revealed.

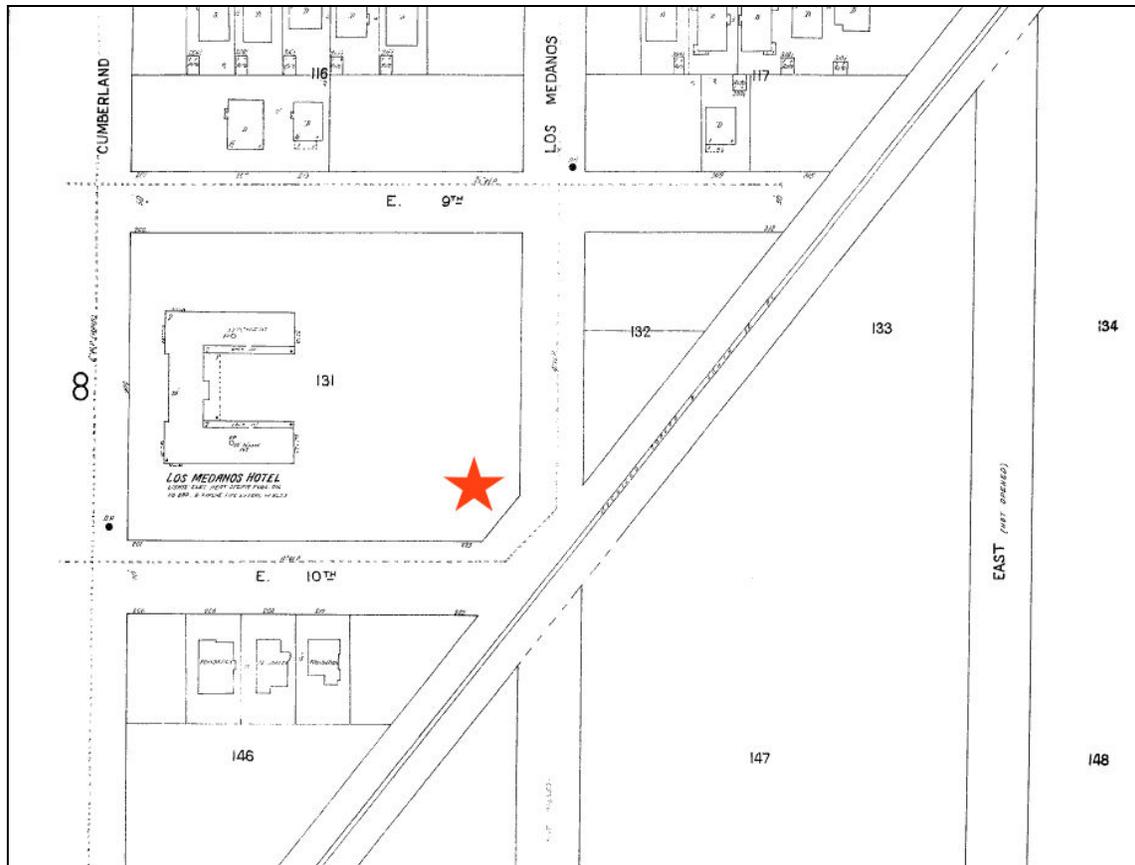
Figure 17: Portion of the 1917 Sanborn Fire Insurance map. Project Area indicated by the red star.

According to Sanborn Fire Insurance maps from 1917, 1927, and a 1949 update of the 1927 map (Figures 17, 19, and 20), and the 1953 USGS 7.5' Honker Bay quadrangle map (Figure 21), no buildings were located within the Project Area during those times; however, development of the city block where the Project Area is located began as early as 1917 with the construction of the Hotel Los Medanos (no longer extant) located to the west of the Project Area (Figure 16 and Figure 17), and the Pittsburg Community Church (still extant) that was constructed north of the Project Area by 1927. The Project Area appears to have remained undeveloped until at least 1959 when a Foster's Old Fashioned Freeze was constructed within the Project Area. Foster's Old Fashioned Freeze remained in operation within the Project Area through the 1970s, and was subsequently closed and reopened as a restaurant until 2008 when the building was demolished (Graening and Ahrens 2019:3).

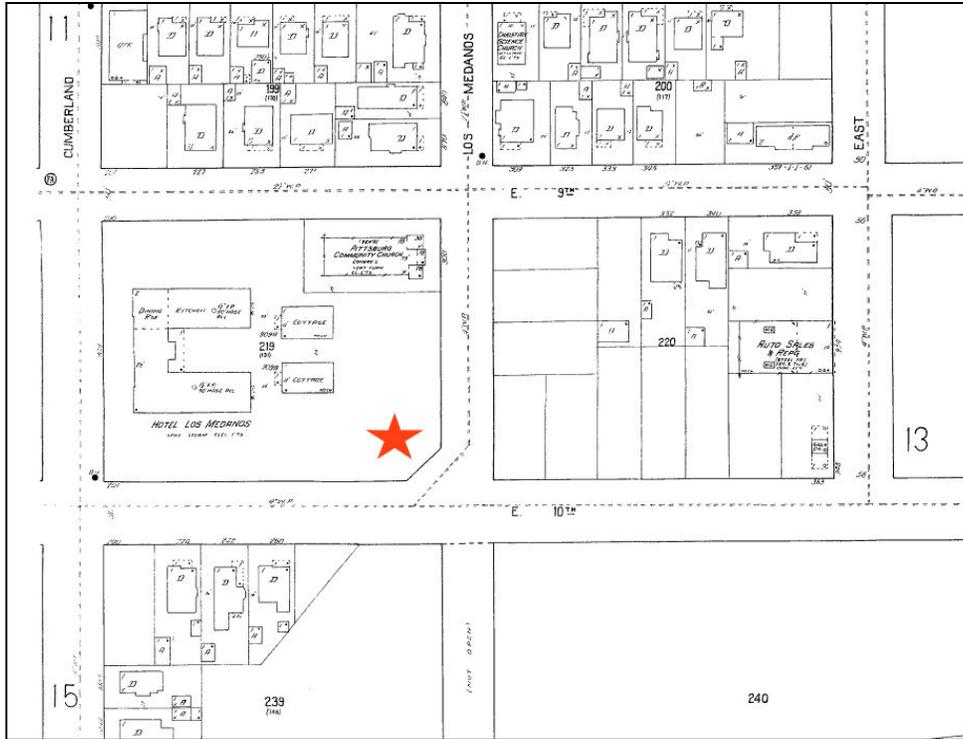
Figure 19: Portion of the 1927 Sanborn Fire Insurance map. Project Area indicated by the red star.

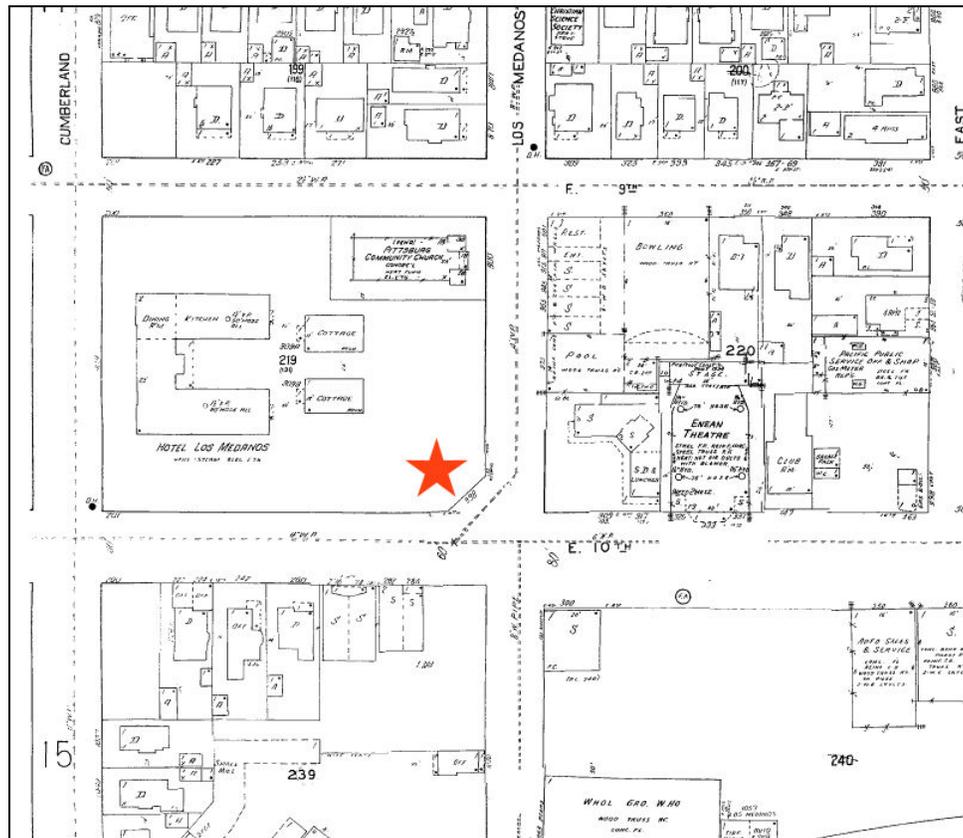
Figure 20: Portion of the 1927 Sanborn Fire Insurance map, updated 1949. Project Area indicated by the red star.

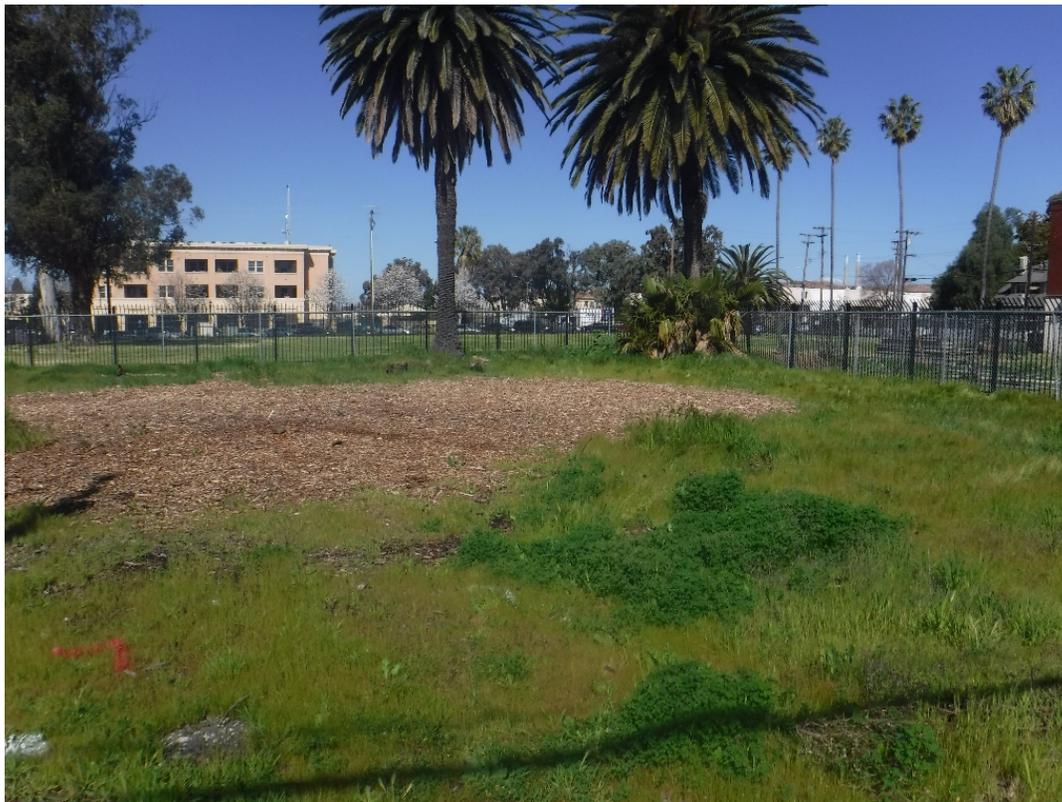
Figure 22: Overview of Project Area, facing west.

No evidence of a prehistoric or historic-era archaeological deposit was observed; however, two large date palm trees are located along the extreme western property line (Figure 22) that, based on previous Sanborn Fire Insurance maps, appear to be associated with one of two cottages (no longer extant) that were within the property of the former Los Medanos Hotel and west of the Project Area in 1927. Several additional large palm trees are also located along East 10th Street south of the Project Area that also appear to be associated with the former Los Medanos Hotel (Figure 22).
