## SUPPLEMENTAL FAULT EXPLORATION

OAK KNOLL  
OAKLAND, CALIFORNIA

**June 23, 2015**

**Project No:**  
5750.300.000

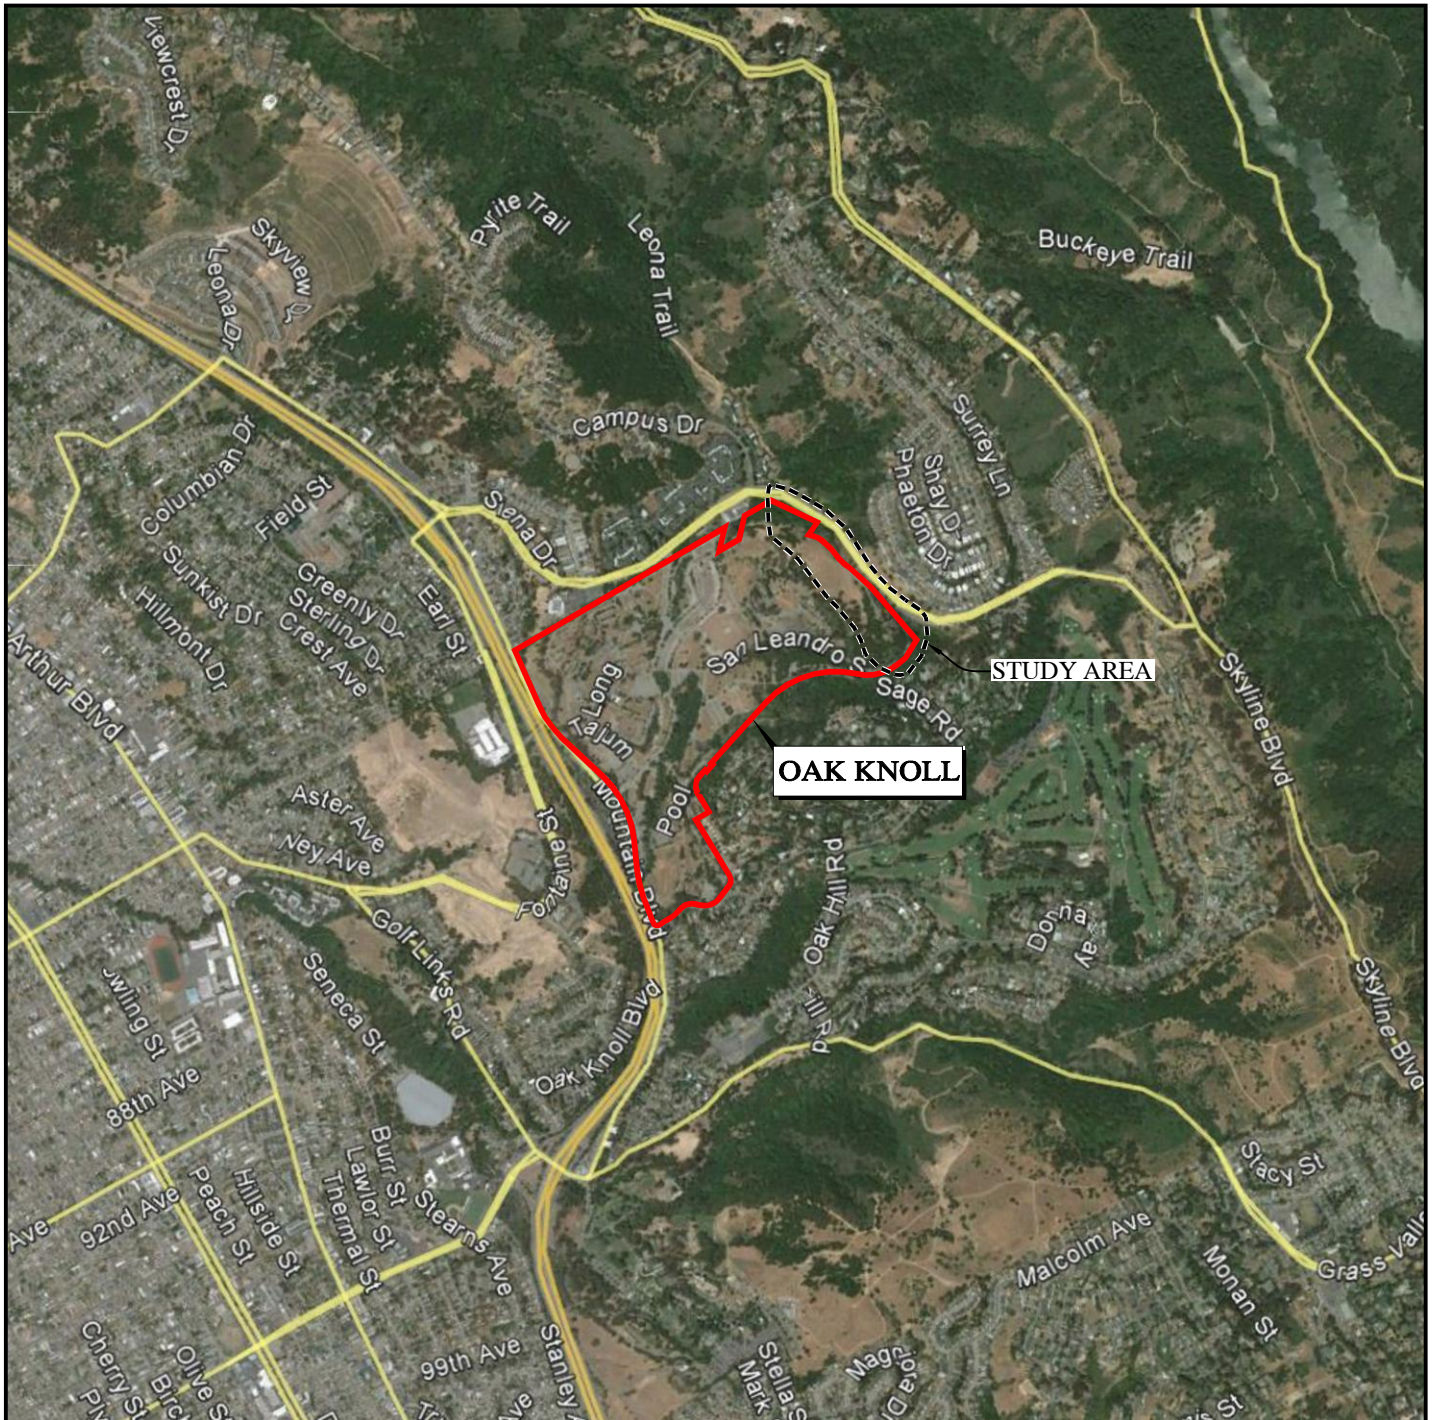
FIGURE NO.  
2

The field exploration for this study was conducted on June 3 and 4, 2015, and consisted of excavating one exploratory trench and two test pits at the approximate locations shown on Figure 2. The trench location was obtained by GPS coordinates and taping from existing fence lines shown on the site plan and should be considered accurately located to the degree implied by the method used.

A fault zone was not encountered within our trench or test pits excavated at the site. The test pits and trench indicate that the contact between the Jurassic Volcanics and the Knoxville Formation is located east of site boundary at the southeast portion of the site as shown on Figure 2. Mapping along the west side of Keller Avenue further constrain the location of the contact.

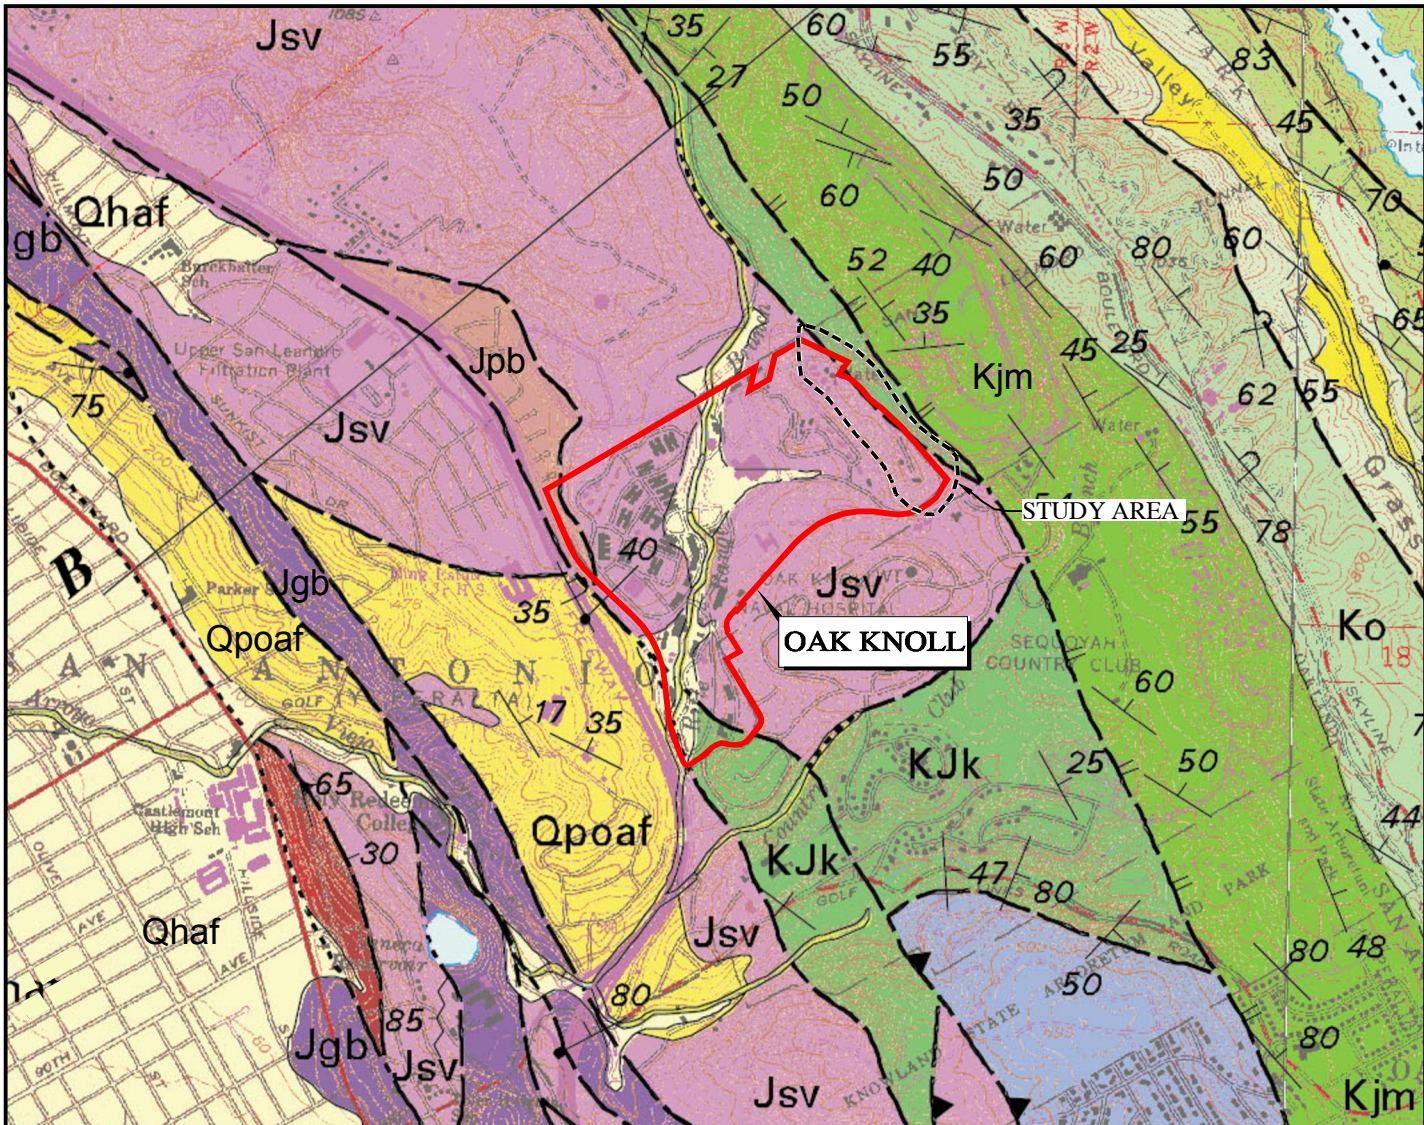
The site is located in the Coast Ranges geomorphic province of California. In this part of the province, bedrock is mapped predominantly as late Jurassic-age keratophyre and quartz keratophyre, a fine-grained volcanic rock (Figure 3 - Graymer, 2000). Late Jurassic and early

One of the mapped faults crosses a relatively small area near the eastern edge of the site. As previously discussed, this fault was not evaluated in conjunction with previous exploration of the site. According to Radbruch (1969), and Dibblee (2005) the subject fault is the Chabot fault. The Chabot fault represents a bedrock discontinuity that juxtaposes rocks of the Jurassic Coast Range ophiolite, the Franciscan complex and lower portions of the Great Valley sequence against Late Cretaceous and Tertiary bedrock units. In the vicinity of the site Graymer (2000) maps a western splay of the Chabot fault that juxtaposes Late Jurassic Keratophyre of the Coast Range ophiolite against a sliver of Late Jurassic to Early Cretaceous Knoxville formation. This western fault splay is mapped along the eastern boundary of the site. According to Graymer (2000) and the USGS 2008 National Seismic Hazard Maps, the main trace of the Chabot fault is mapped approximately 200 feet northeast of the eastern boundary of the site along the southwest facing cut slope along the east side of Keller Avenue (Figure 3).
