Location:	7196 Saroni Drive
Assessor's Parcel Number:	048E-7330-003-00
Proposal:	Appeal of Zoning Manager's approval of a Creek Protection Permit to construct biotechnical bank stabilization, consisting of rock riprap, biodegradable erosion control blankets, and vegetative rootwads, to stabilize incising banks of an existing stream tributary of Shepherd Creek; to construct retaining walls to stabilize local slide erosion below a residence; and to incorporate biotreatment, revegetation, and stormwater dissipation measures to reduce erosion, sedimentation, and protect the stream channel bank.
Appellant:	Nicholas Vigilante
Phone Number:	510-339-6855
Owner:	Jansen Lum
Planning Permits Required:	Category IV Creek Protection Permit, Section 13.16 of the City of Oakland Creek Protection Ordinance.
General Plan:	Hillside Residential
Zoning:	RH-4/S-9
Environmental Determination:	Exempt, Section 15269(c) of the State CEQA Guidelines – Emergency Projects; Section 15301(d) Existing Facilities; Section 15183 of the State CEQA Guidelines: Projects Consistent with a Community Plan, General Plan or Zoning

On February 4, 2019, the appellant filed a timely appeal (Attachment A) requesting that the

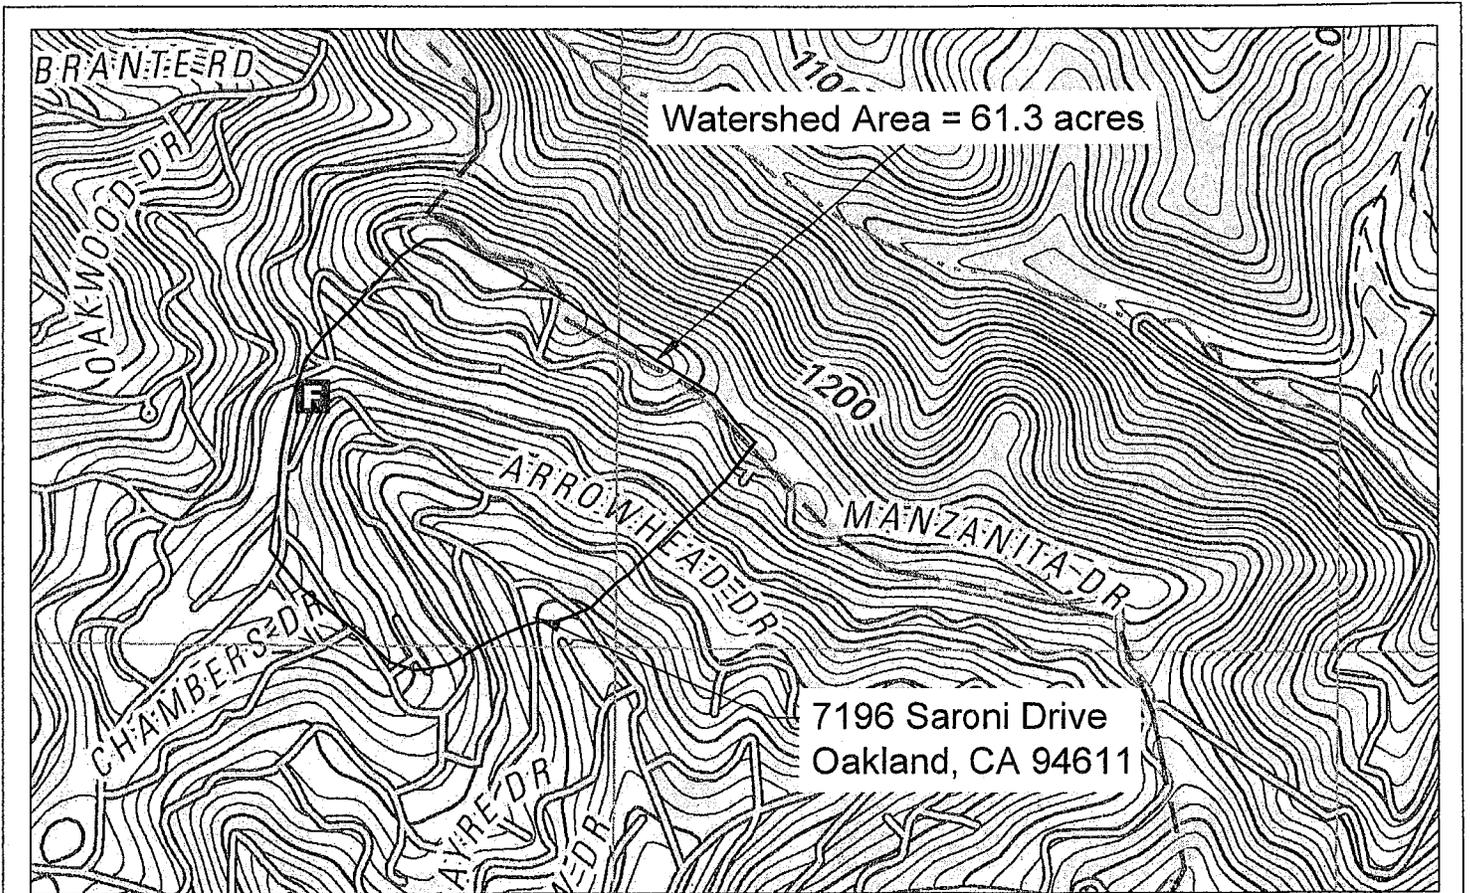
Figure 2 : Watershed Map

Information Source: USGS Topographic Map

The on-site tributary to Shepard Creek supports intermittent flow during the winter season which typically extends from Nov. - March. The 61.3-acre tributary watershed is delineated on the USGS 7.5-min. Oakland East quadrangle in Figure 2. The tributary valley upstream of the property reach has been filled for hillside residential and watershed runoff is conveyed through the valley fill in a storm drain system. This system discharges along the southern edge of the neighboring Vigilante property into the above-ground creek that then traverses the Lum property as it continues in a south-southeastly direction toward Shepard Canyon Road and Shepard Creek. Shepard Creek joins with Palo Seco Creek just west of the CA Highway 13 crossing to form Sausal Creek. Sausal Creek drains portions of the Diamond, Highland Park and Fruitvale Districts before entering a storm drain system through the commercial areas along I-880 and discharging to East Creek Slough and the Oakland Inner Harbor.

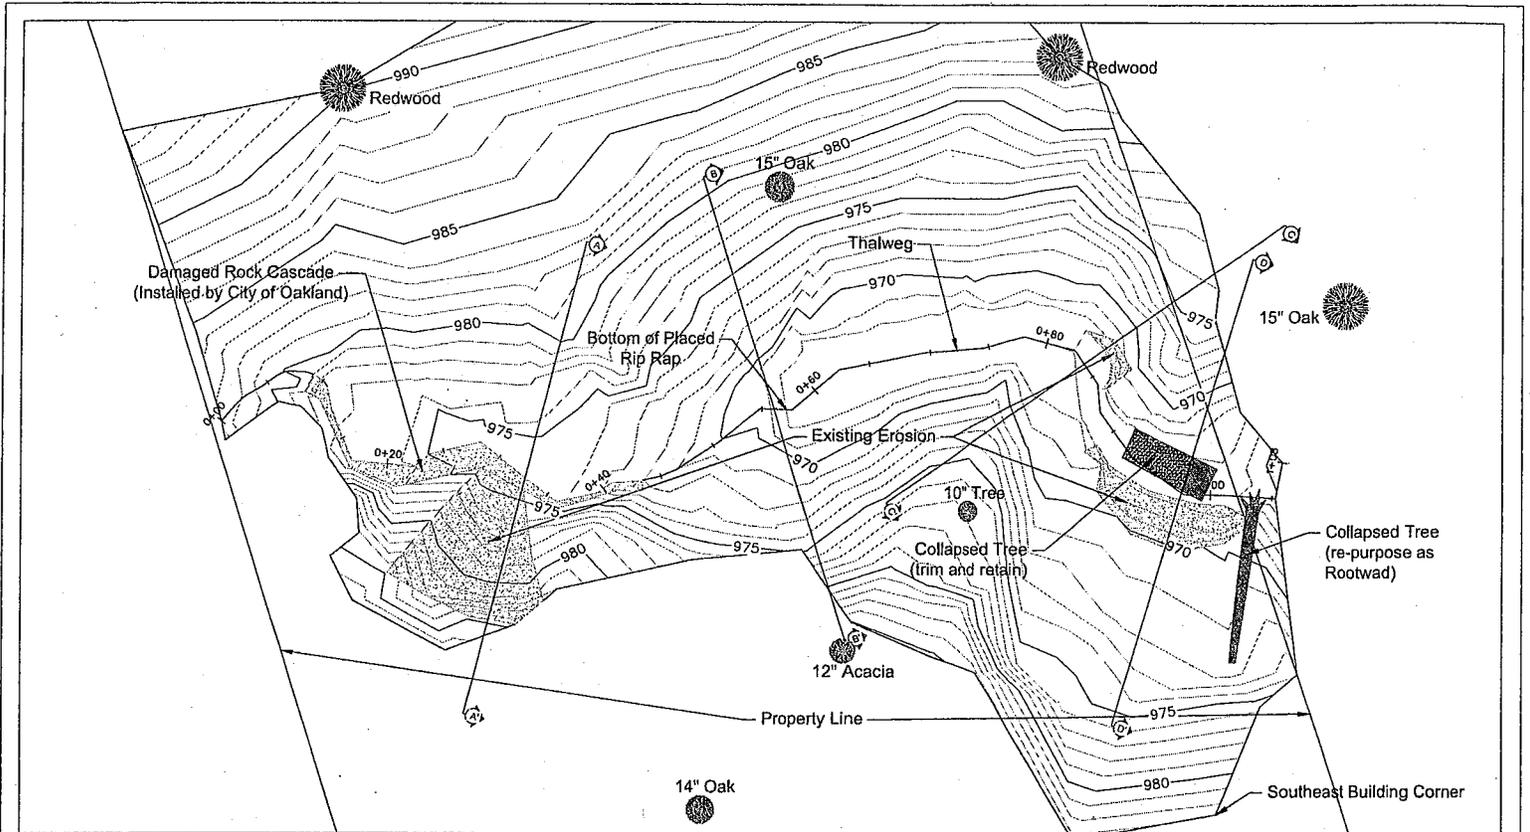
Figure 3 : Existing Conditions and Topography

Information Source: CH August 2018 Survey

CH staff conducted a total station topographic survey of the intermittent creek and its adjoining hillslopes on Aug. 15, 2018. The site topographic mapping is shown along with indicated hydrogeomorphic features in Figure 3: Existing Conditions and Topography. Aside from a short stream terrace that flanks the right bank downslope of the main landslide area, the hillslopes

The longitudinal channel profile is shown in the upper portion of Plan Sheet 1. It comprises two steep segments. The upper approximately 60 ft. is extremely steep at 26%, while the lower remaining sub-reach has a composite slope of 6.7%, which is still very steep. The excessively steep upper sub-reach is partially reinforced by a rock cascade constructed by the City of Oakland (Photo 2). Its installation pre-dates the 2016-2017 winter. The right side (looking downstream) of the cascade has been side-cut by floodflows and the larger elements placed over this portion of the cross-section have collapsed, leaving a gully with fine-grained materials exposed on the cut-bank and the now-exposed channel bed (Photo 3). The left side of the cascade appears to be relatively stable. This avulsing of the channel reinforcement most likely triggered the slump failure on the right hillslope which fords stream stations 0+20 to 0+33 (see Figure 3, Photo 3).

Project Side Condition. Aside from a short stream terrace that flanks the right bank at the downstream end of the Lum property, the hillslopes adjoining the well-incised channel are steep, at roughly 1:1 (Photo 1 in Attachment A). The Lum property reach of the creek is about 110 feet long. The longitudinal channel profile is shown in the upper portion of Plan Sheet 1 in Attachment B. It comprises two steep segments. The upper 60 feet long segment has an extremely steep slope of 26 percent, while the lower remaining sub-reach has a composite slope of 6.7 percent, which is still very steep. The excessively steep upper sub-reach is partially reinforced by a rock cascade constructed by the City of Oakland (Photo 2 in Attachment A). Its installation pre-dates the 2016-2017 winter. The right side (looking downstream) of the cascade has been side-cut by flood flows and the larger elements placed over this portion of the cross-section have collapsed, leaving a gully with fine-grained materials exposed on the cut-bank and the now-exposed channel bed (Photo 3 in Attachment A). The left side of the cascade appears to be relatively stable. This avulsing of the channel reinforcement most likely triggered a slump failure on the right hillslope which fords stream stations 0+20 to 0+33 (see Figure 3 and Photo 3 in Attachment A).

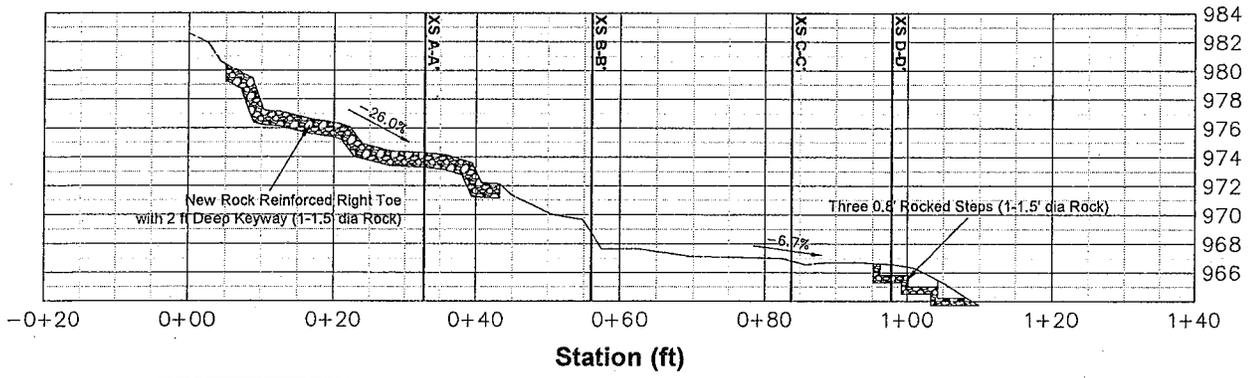
1 LONGITUDINAL PROFILE: From Upper to Lower Property Boundary

Elevation (ft)
City of Oakland Datum

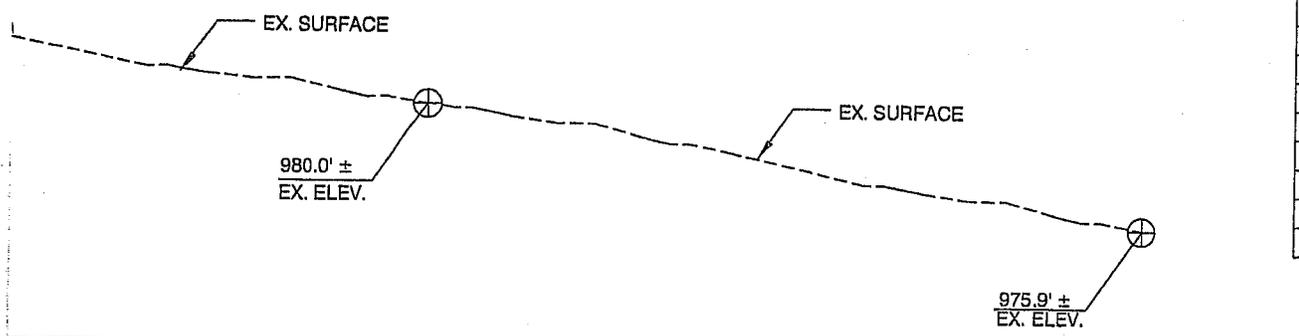
CONSTRUCTION PLAN
217B

1. THE SIZE OF THE RIP-RAP SHALL BE 24" ± IN DIAMETER AND THE WEIGHT SHALL BE 500 LB. ± ACCORDING TO SECTION 200-1.6 OF THE STANDARD SPECIFICATIONS.
2. THE LOCATION OF RIP-RAP WILL BE DETERMINED IN THE FIELD BY THE ENGINEER.
3. MEASUREMENT AND PAYMENT: THE CONTRACT UNIT PRICE PAID PER TON FOR "FURNISH AND INSTALL 24" DIA. ROCK (500 LB. ± EACH) AT 7198 SARONI DRIVE STORM DRAIN OUTLET" SHALL INCLUDE FULL COMPENSATION FOR FURNISHING ALL LABOR, MATERIALS, AND DOING ALL WORK INCLUDING EXCAVATION, DISPOSAL OF WASTE MATERIALS, BACKFILL AND ALL OTHER INCIDENTAL WORK INVOLVED IN FURNISHING AND INSTALLING THE RIP-RAP, COMPLETE IN PLACE AS SHOWN ON THE PLANS AND AS SPECIFIED IN THE STANDARD SPECIFICATIONS, AND THE SPECIAL PROVISIONS, OR AS DIRECTED BY THE ENGINEER.

KEYWAY
TYPICALLY 4'x2'x8'

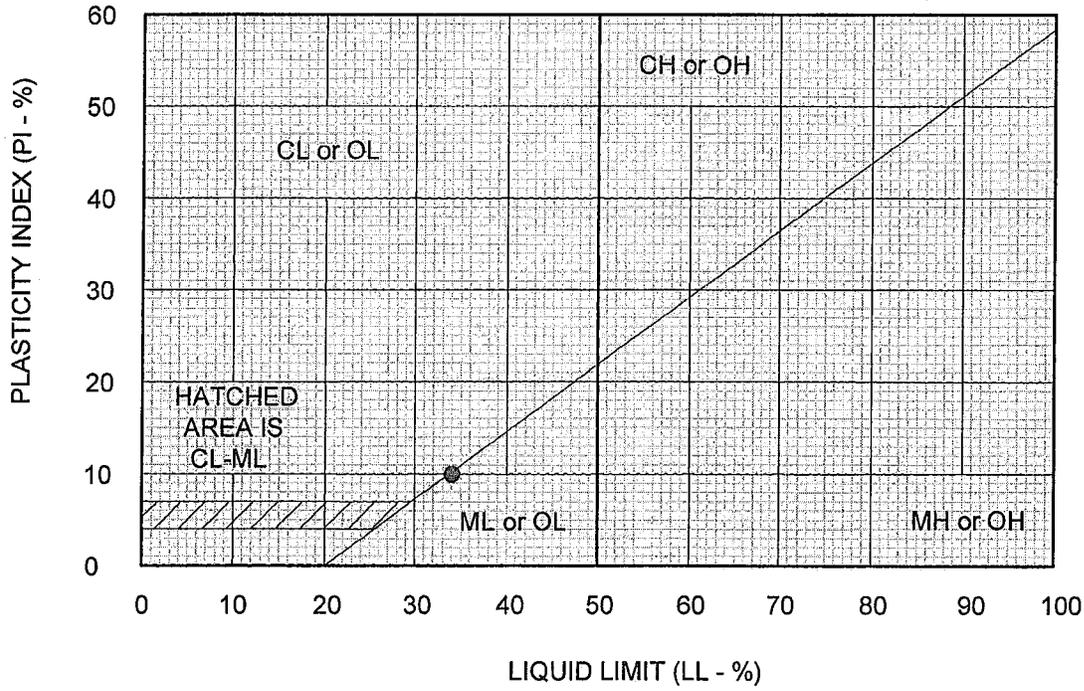
LIQUID AND PLASTIC LIMITS TEST REPORT

Sample Location & Description	LL	PL	PI	-200	Soil Classification
● Boring 1: 1.5' - 2.0': Landslide: silty and clayey Sand	34	24	10		SC

The percent passing the No. 200 sieve was determined on 2 samples of the native soils to assist in the proper classification of these materials as either predominantly granular sands or fine-grained silts or clays in terms of composition by measuring the overall percentage of fines as well as the sand and gravel fractions. These tests were performed in accordance with ASTM Test Designation D-1140 and the results are shown on the boring log at the appropriate sample depths.

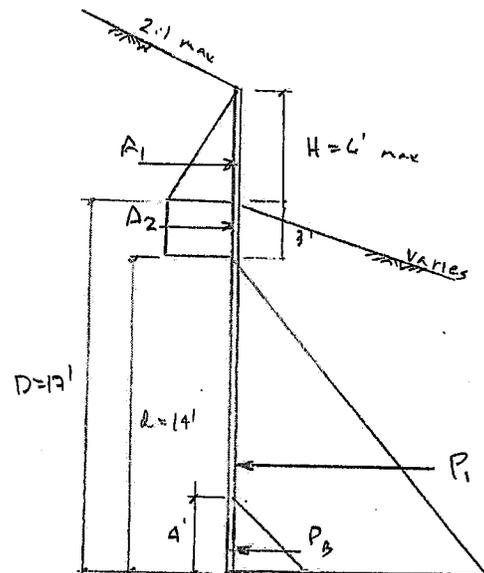
$$P_B = \frac{1}{2} (\gamma_B) d^2 \cdot 2\phi = 3.6 \text{ k}$$

since $\Sigma P \gg \Sigma A$, sliding ok by inspection, over turning controls.

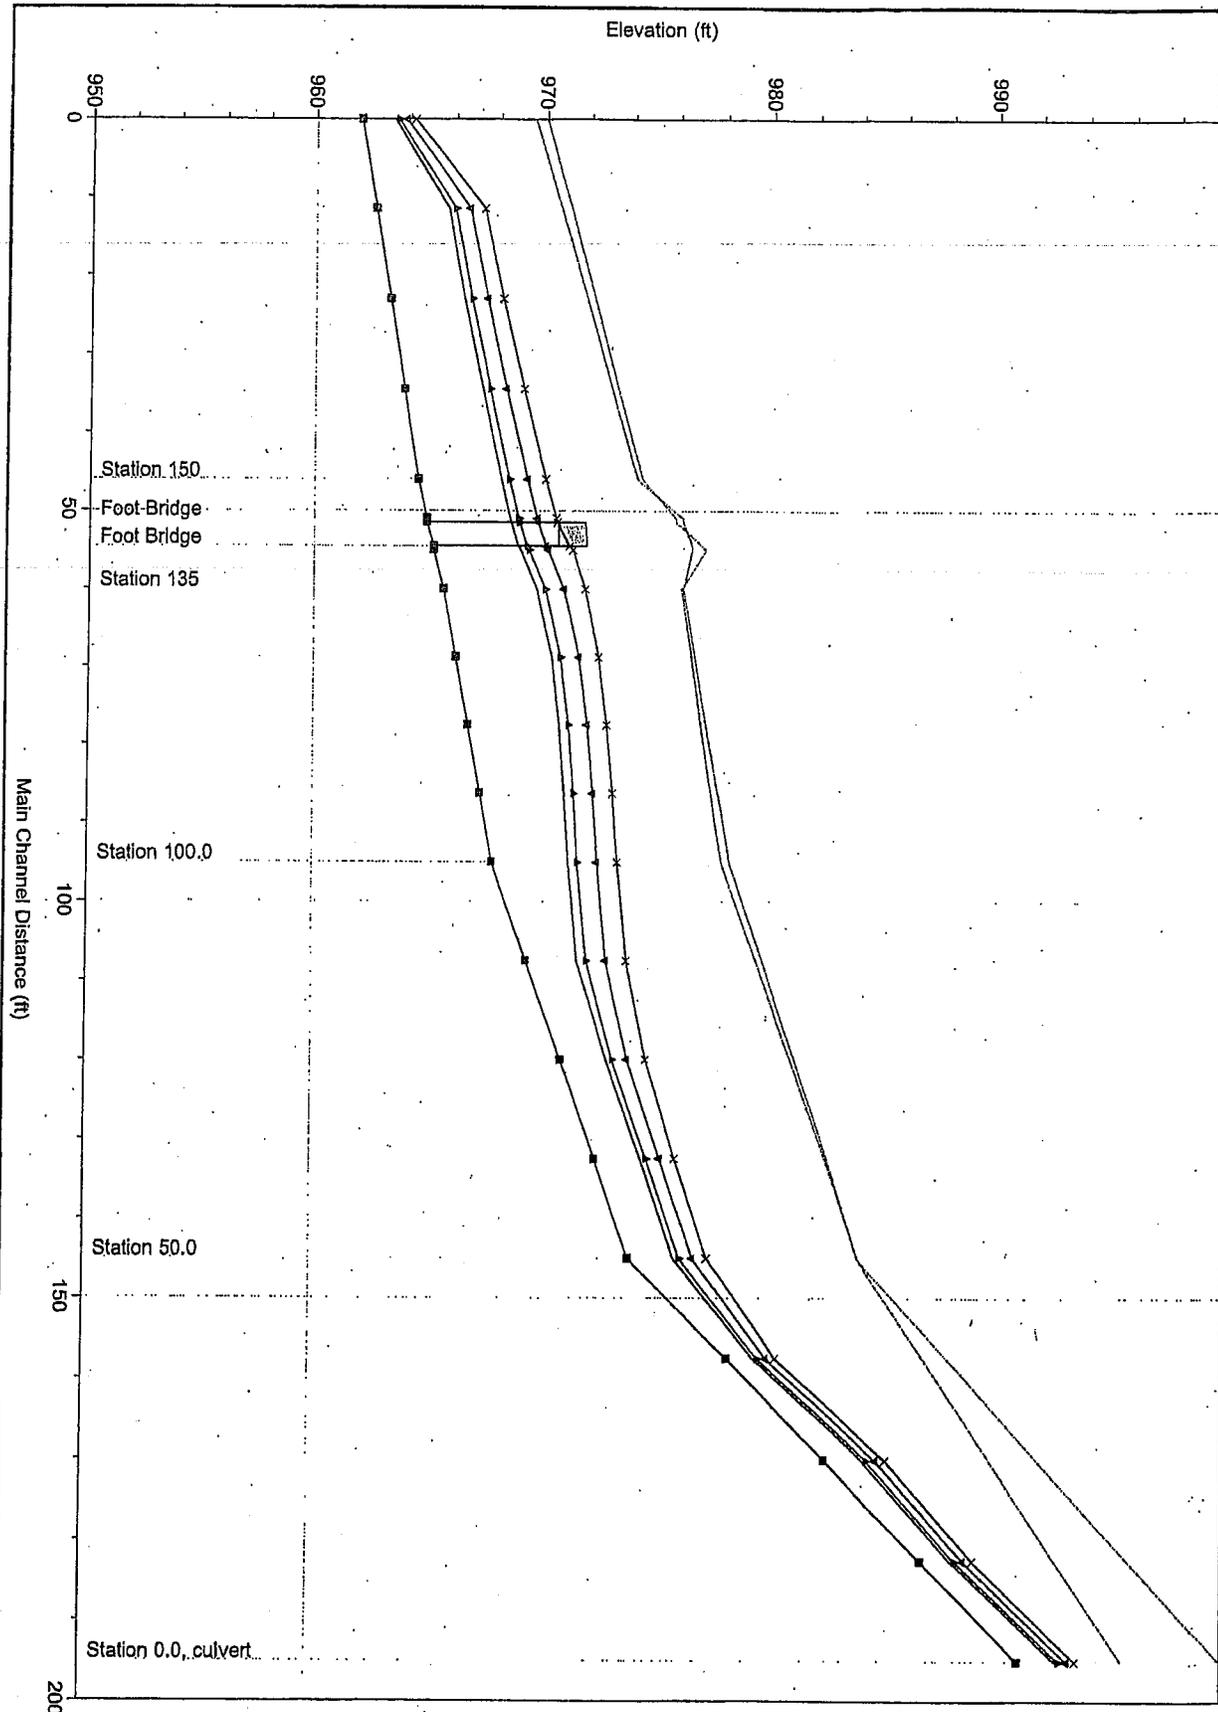
JANSEN LUM HYDROLOGY REPORT Plan: plan 4/4/2007
 HEC-RAS WSEL Figure

Shepard Creek unnamed tributary

Legend	
WS	100 yr.
WS	25 yr.
WS	10 yr.
WS	5 yr.
Ground	LOB
ROB

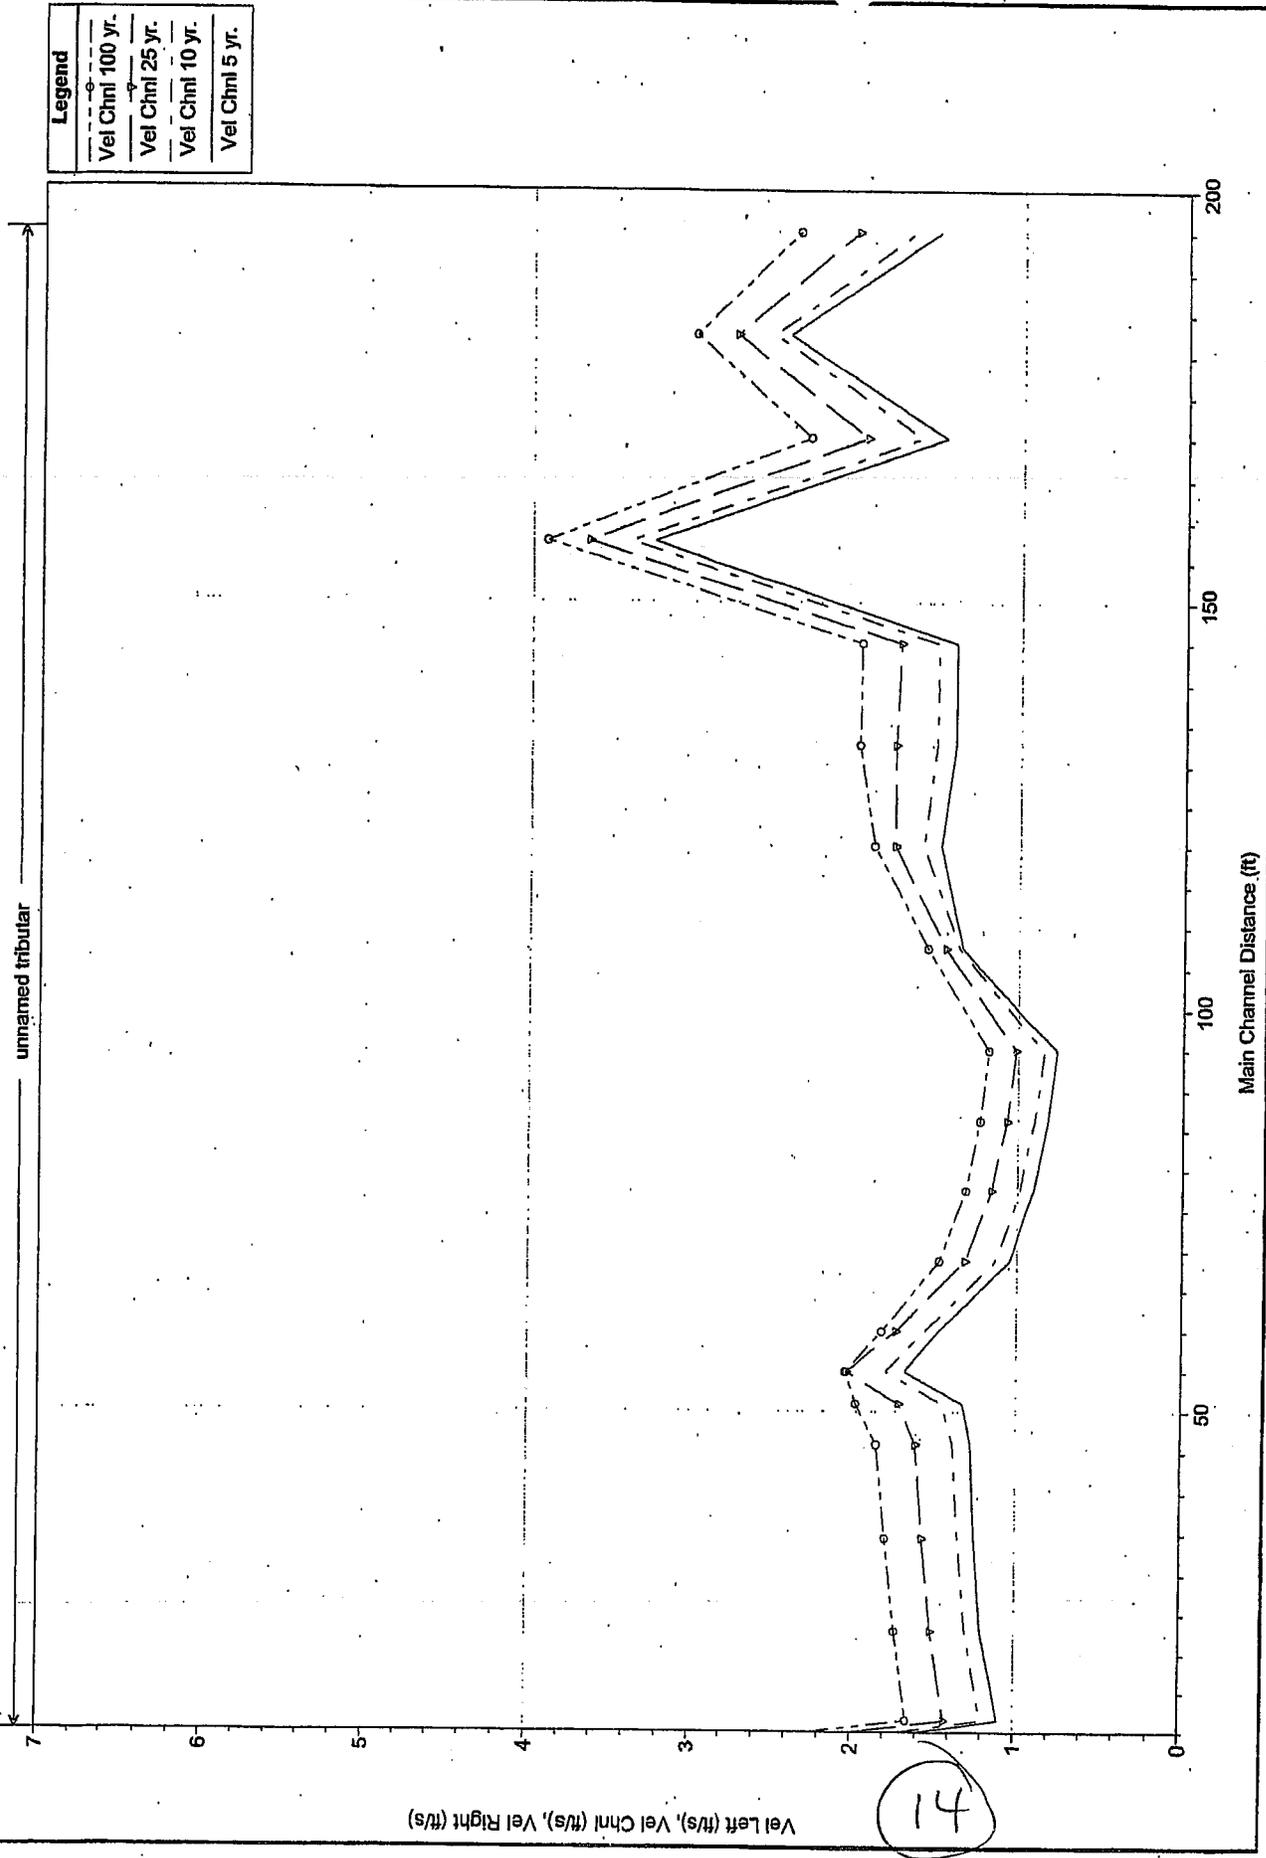
JANSEN LUM HYDROLOGY REPORT Plan: plan 4/4/2007
HEC-RAS Velocity Figure

---○---	Vel Chnl 100 yr.
---△---	Vel Chnl 25 yr.
---▽---	Vel Chnl 10 yr.
---	Vel Chnl 5 yr.

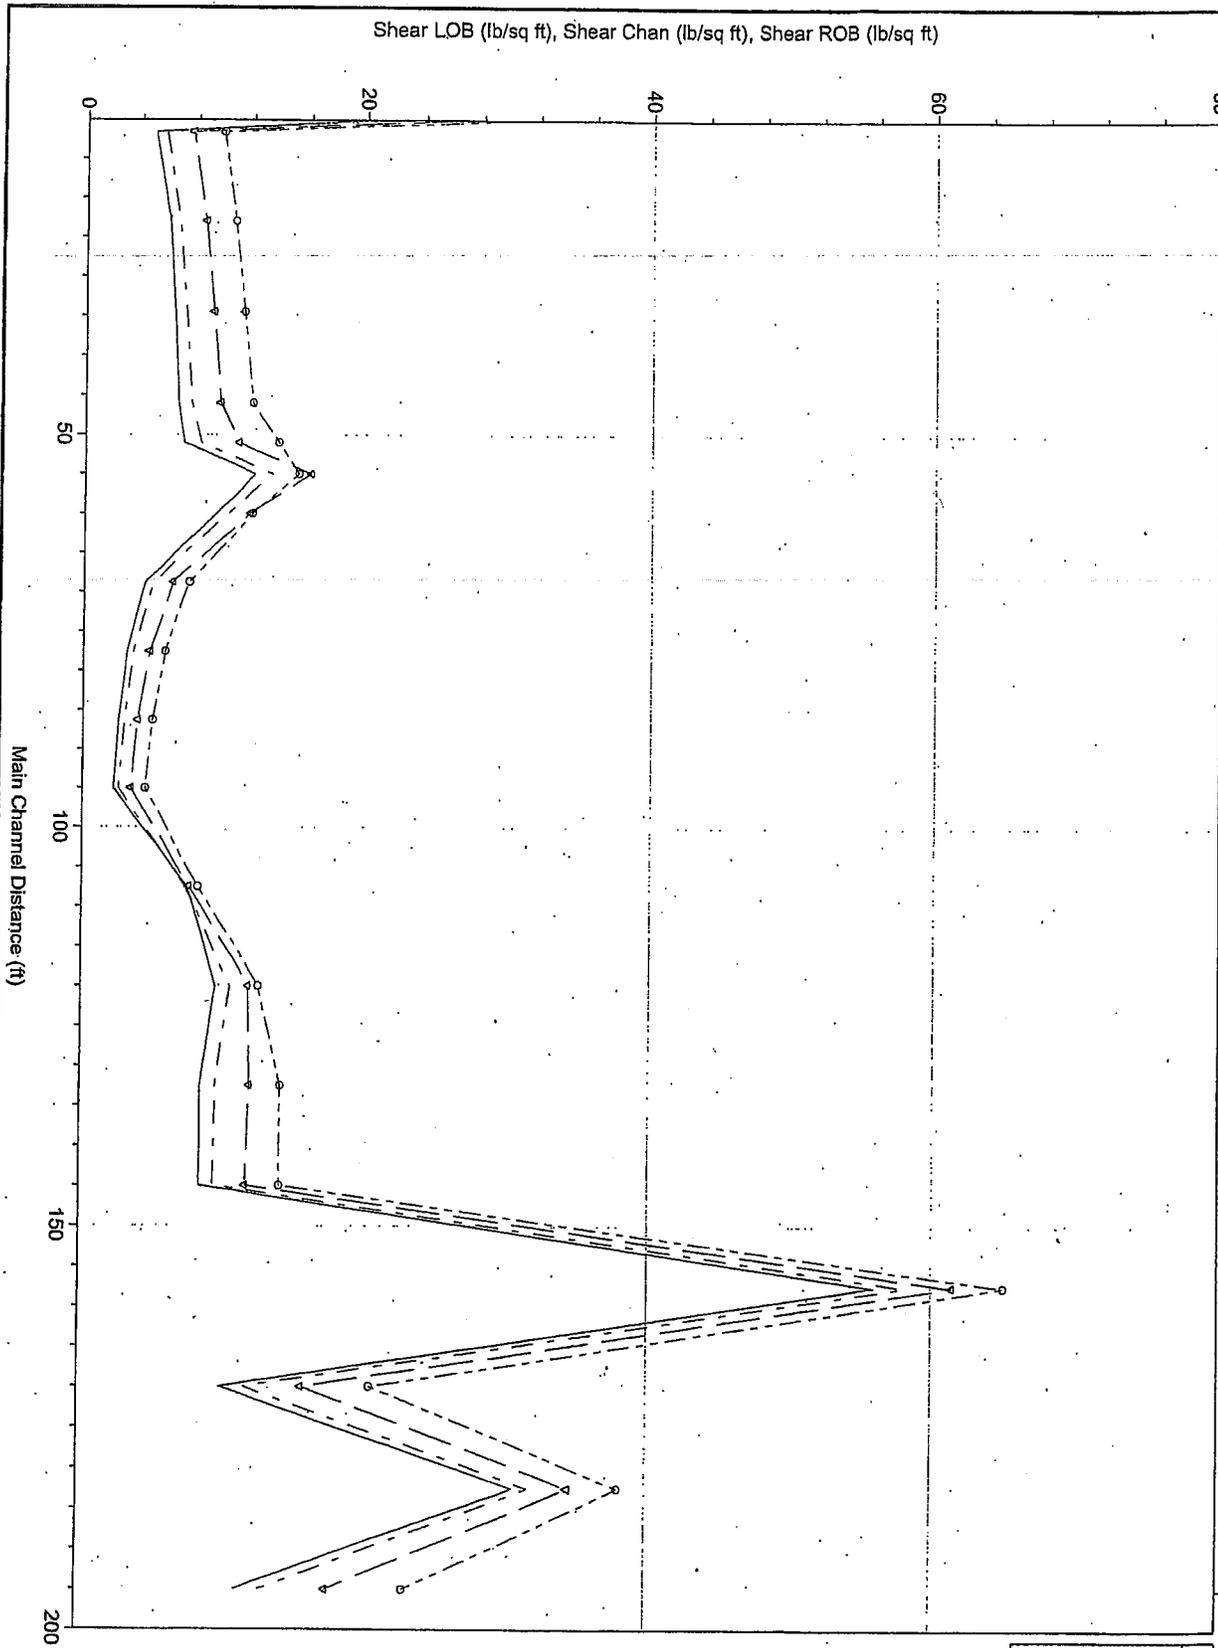
JANSEN LUM HYDROLOGY REPORT Plan: plan 4/4/2007
 HEC-RAS Shear Stress Figure

Legend	
---○---	Shear Chan 100 yr.
—■—	Shear Chan 25 yr.
---△---	Shear Chan 10 yr.
---	Shear Chan 5 yr.

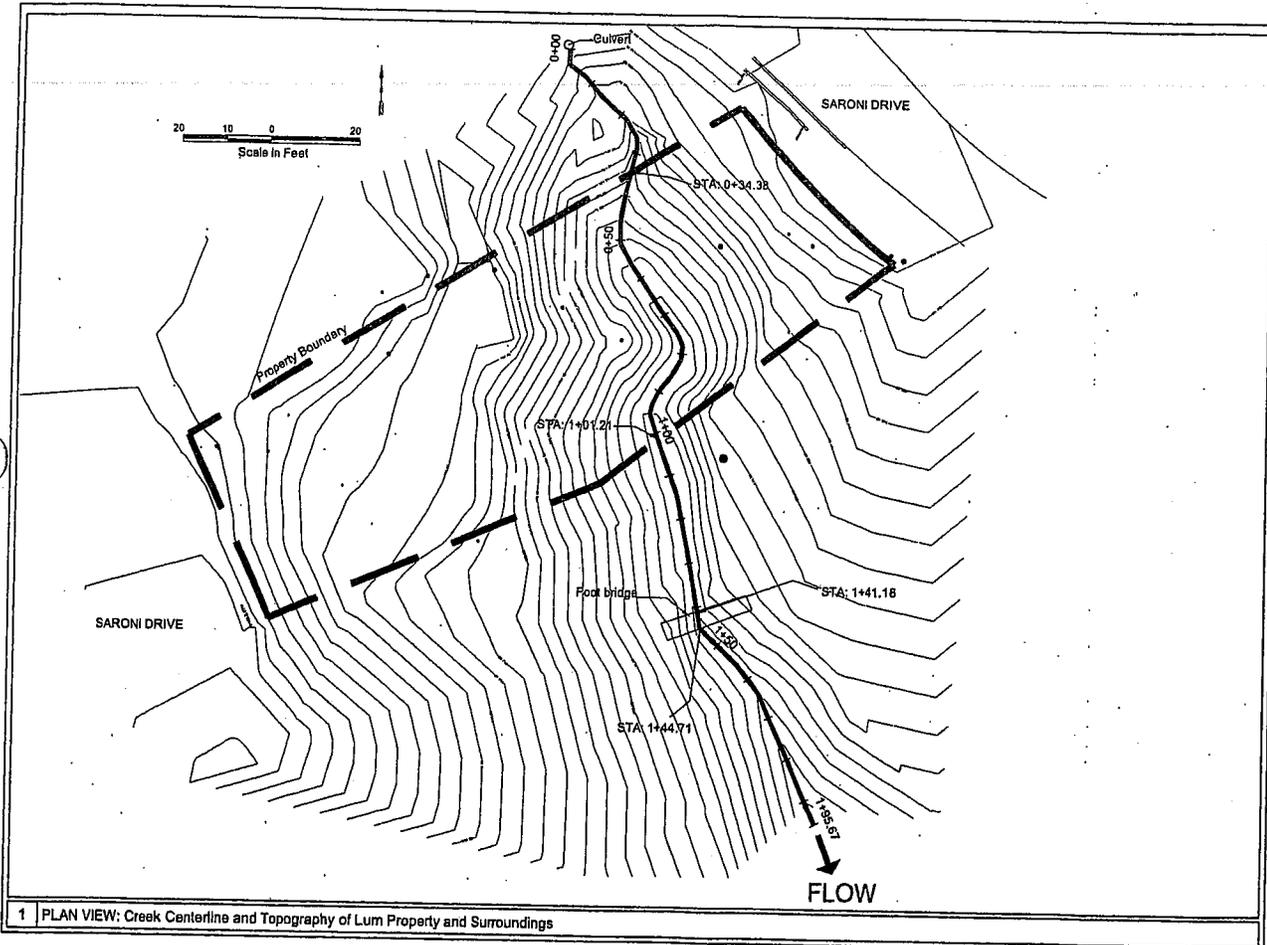
1 PLAN VIEW: Creek Centerline and Topography of Lum Property and Surroundings

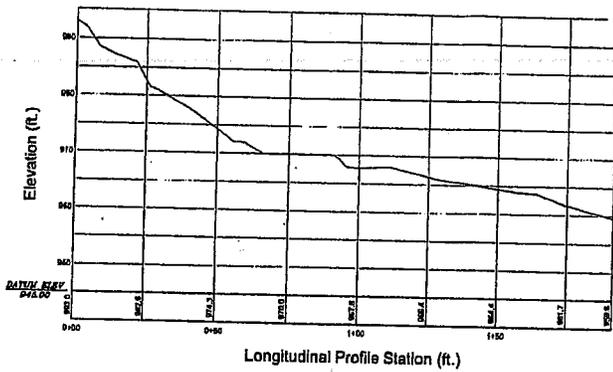
1 LONGITUDINAL PROFILE (LP): Tributary of Shepard Creek across Lum Property

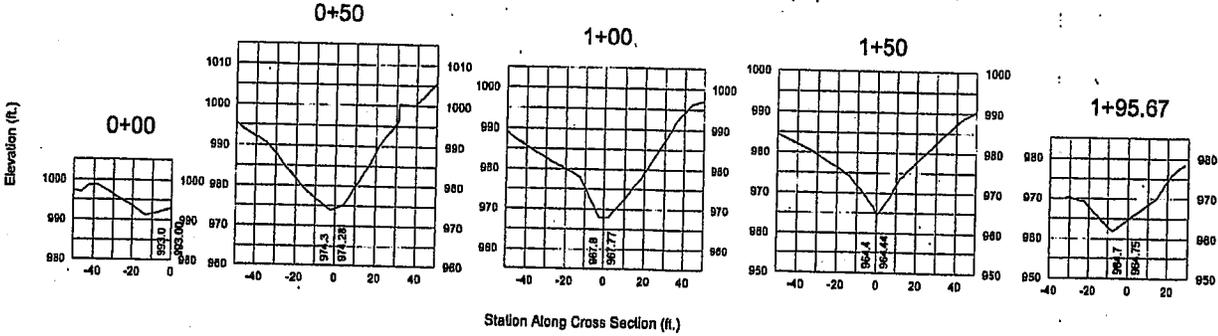
Cross Sections Identified by Station Along Longitudinal Profile (LP)

2 CROSS SECTIONS: Cross Sections from selected stations along creek profile

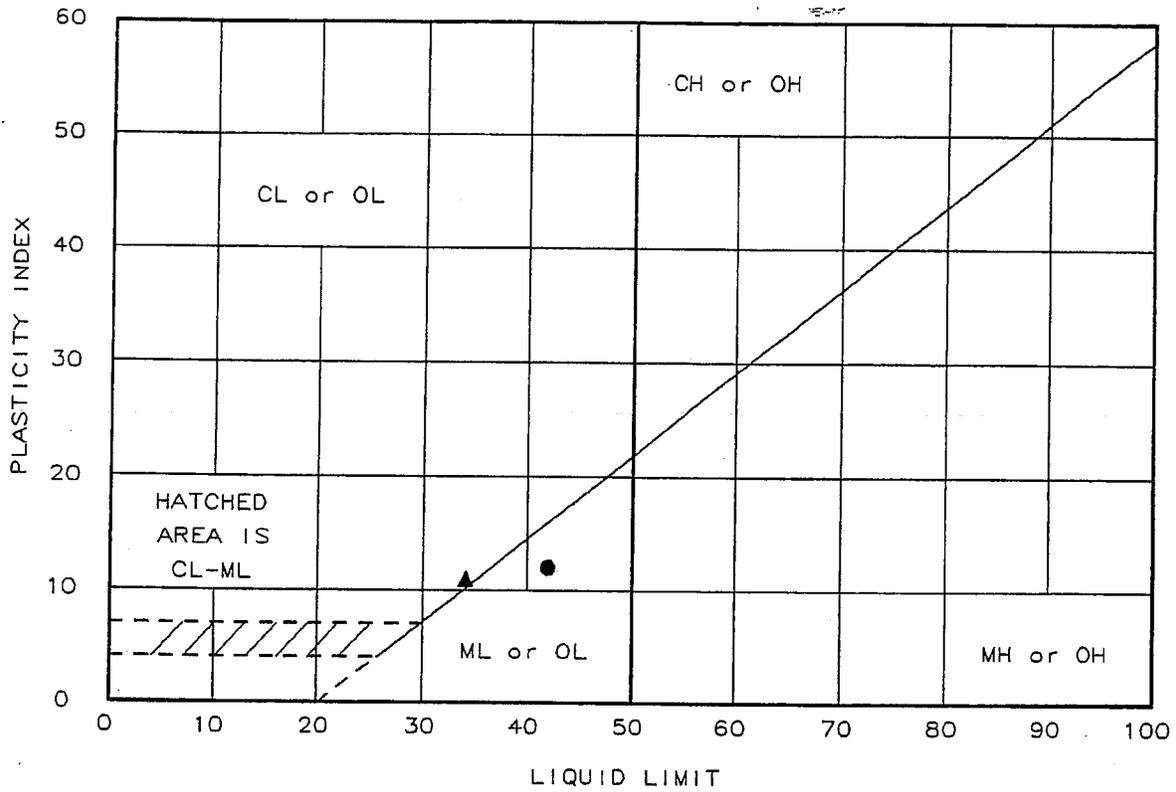
LIQUID AND PLASTIC LIMITS TEST REPORT

Sample Location & Description	LL	PL	PI	-200	Soil Classification
● Boring 1, 10.5 ft., Dark Brown to Black Native Topsoil	42	30	12		ML
▲ Boring 2, 10.0-10.5 ft., Dark Brown to Black Native Topsoil	34	23	11		CL/ML

Unconfined compression tests were performed on 2 relatively undisturbed samples of the native colluvial soil to estimate the undrained shear strength (cohesion) of these materials. The unconfined tests are used to evaluate the relative in-situ compressive strength of the clay soil and were performed in accordance with ASTM test designation D-1266. The unconfined strength was taken as the peak normal stress at 2% strain. The results of these tests are presented on the boring logs at the appropriate sample depths.

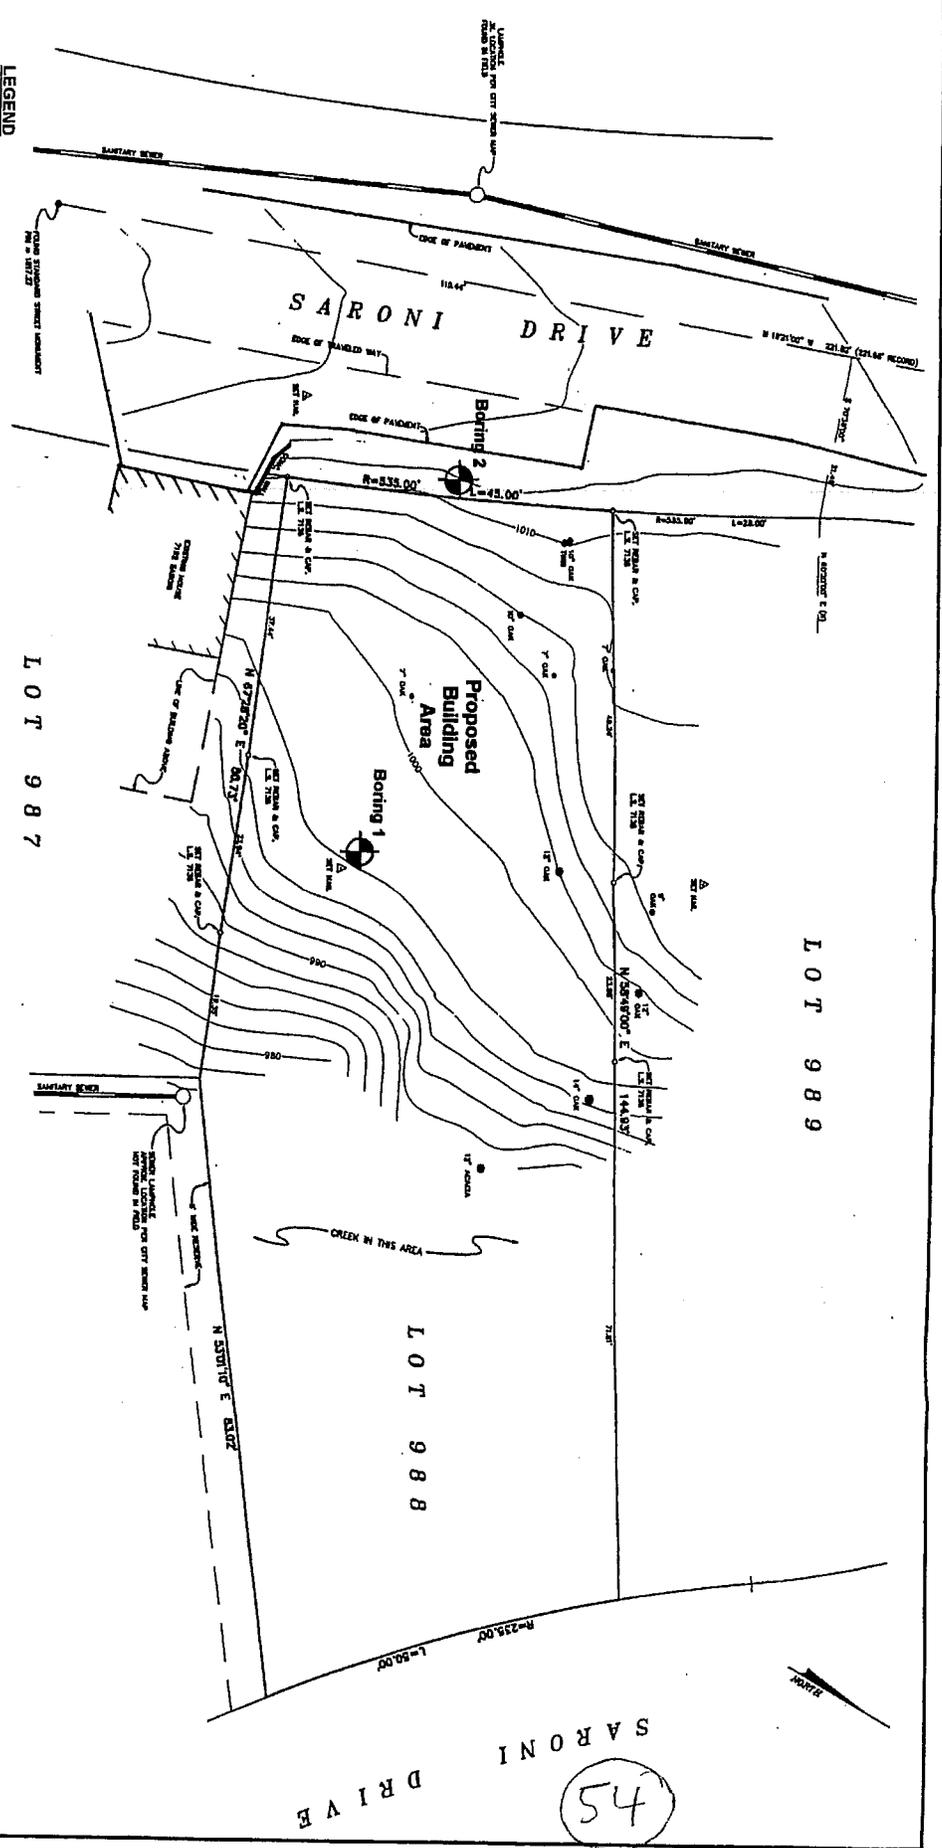
Approximate Location of Exploratory Boring

BASE: "Partial Boundary and Topographic Survey... Lot 988... 7188 Saroni Drive" prepared by Vegvary and Vegvary and dated 9/29/00.

The subsurface conditions at the subject site were investigated by drilling and sampling a total of two exploratory borings at the approximate locations shown on the Site Plan, Figure 2. The borings were located near the front and rear perimeter of the currently proposed building area on the upper portion of the lot near the street as shown on Figure 2.

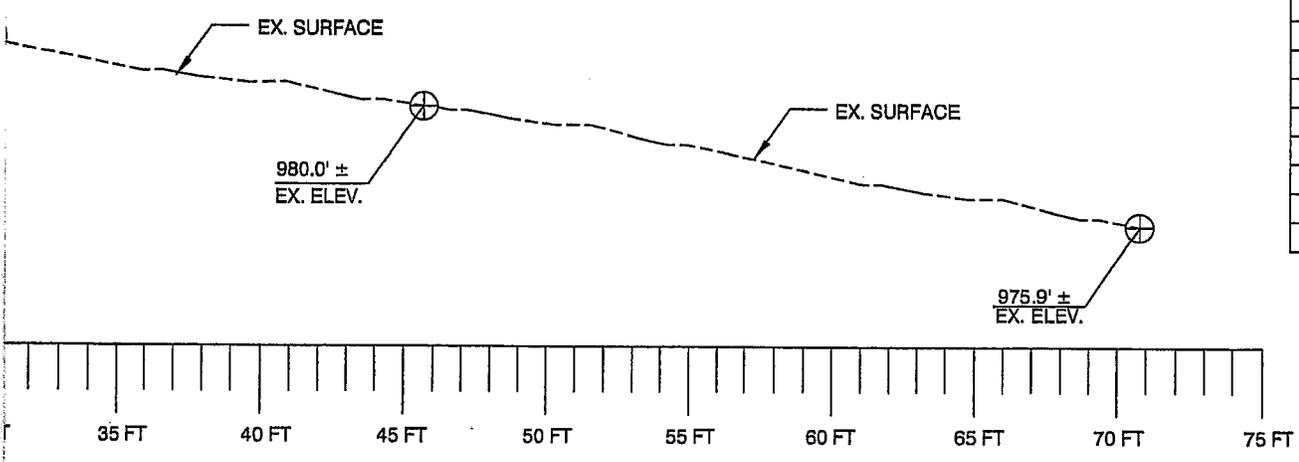
CONSTRUCTION PLAN
217B

1. THE SIZE OF THE RIP-RAP SHALL BE 24" ± IN DIAMETER AND THE WEIGHT SHALL BE 500 LB. ± ACCORDING TO SECTION 200-1.6 OF THE STANDARD SPECIFICATIONS.
2. THE LOCATION OF RIP-RAP WILL BE DETERMINED IN THE FIELD BY THE ENGINEER.
3. MEASUREMENT AND PAYMENT: THE CONTRACT UNIT PRICE PAID PER TON FOR "FURNISH AND INSTALL 24" DIA. ROCK (500 LB. ± EACH) AT 7198 SARONI DRIVE STORM DRAIN OUTLET" SHALL INCLUDE FULL COMPENSATION FOR FURNISHING ALL LABOR, MATERIALS, AND DOING ALL WORK INCLUDING EXCAVATION, DISPOSAL OF WASTE MATERIALS, BACKFILL AND ALL OTHER INCIDENTAL WORK INVOLVED IN FURNISHING AND INSTALLING THE RIP-RAP, COMPLETE IN PLACE AS SHOWN ON THE PLANS AND AS SPECIFIED IN THE STANDARD SPECIFICATIONS, AND THE SPECIAL PROVISIONS, OR AS DIRECTED BY THE ENGINEER.

KEYWAY
WIDELY 4' x 2' x 8'

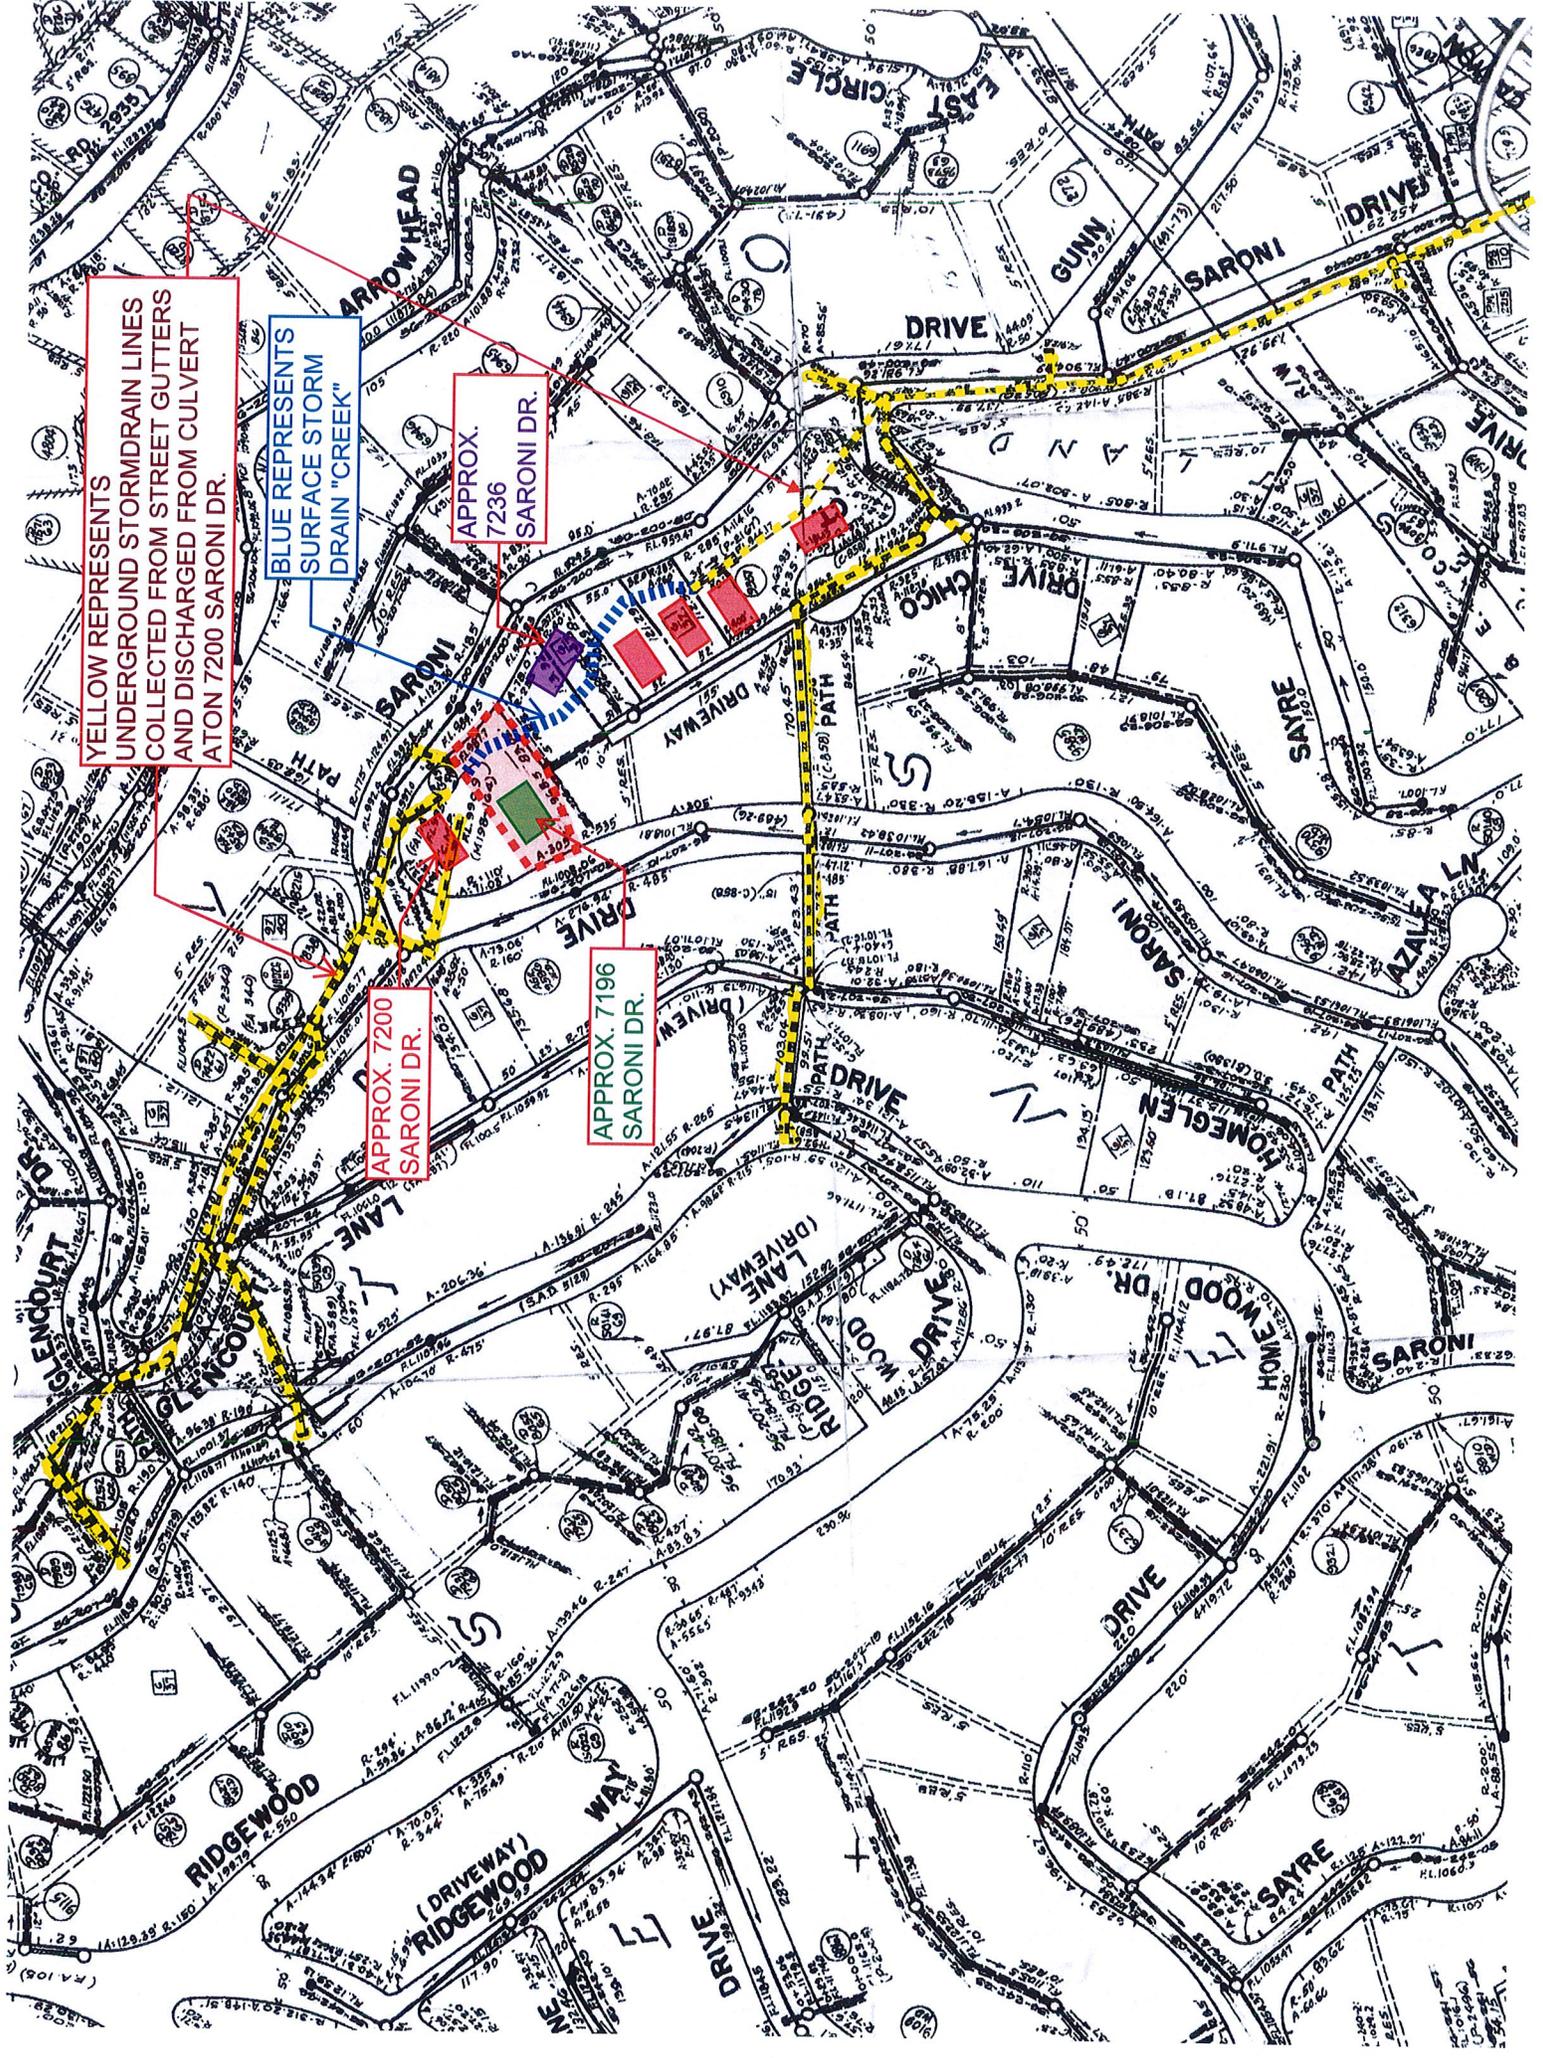
RETAINING WALL & CREEK PROTECTION LOCATIONS PER GEOTECH

INSTALL FIBER ROLL STAKE TO SLOPE
	RIP RAP ROCK RETENTION
	ROCK SIZES APPROXIMATE 8"-12" MINIMUM
	VEGETATION PLANTING
