Location:	7196 Saroni Drive
Assessor's Parcel Number:	048E-7330-003-00
Proposal:	Appeal of Zoning Manager's approval of a Creek Protection Permit to construct biotechnical bank stabilization, consisting of rock riprap, biodegradable erosion control blankets, and vegetative rootwads, to stabilize incising banks of an existing stream tributary of Shepherd Creek; to construct retaining walls to stabilize local slide erosion below a residence; and to incorporate biotreatment, revegetation, and stormwater dissipation measures to reduce erosion, sedimentation, and protect the stream channel bank.
Appellant:	Nicholas Vigilante
Phone Number:	510-339-6855
Owner:	Jansen Lum
Planning Permits Required:	Category IV Creek Protection Permit, Section 13.16 of the City of Oakland Creek Protection Ordinance.
General Plan:	Hillside Residential
Zoning:	RH-4/S-9
Environmental Determination:	Exempt, Section 15269(c) of the State CEQA Guidelines – Emergency Projects; Section 15301(d) Existing Facilities; Section 15183 of the State CEQA Guidelines: Projects Consistent with a Community Plan, General Plan or Zoning

On February 4, 2019, the appellant filed a timely appeal (Attachment A) requesting that the

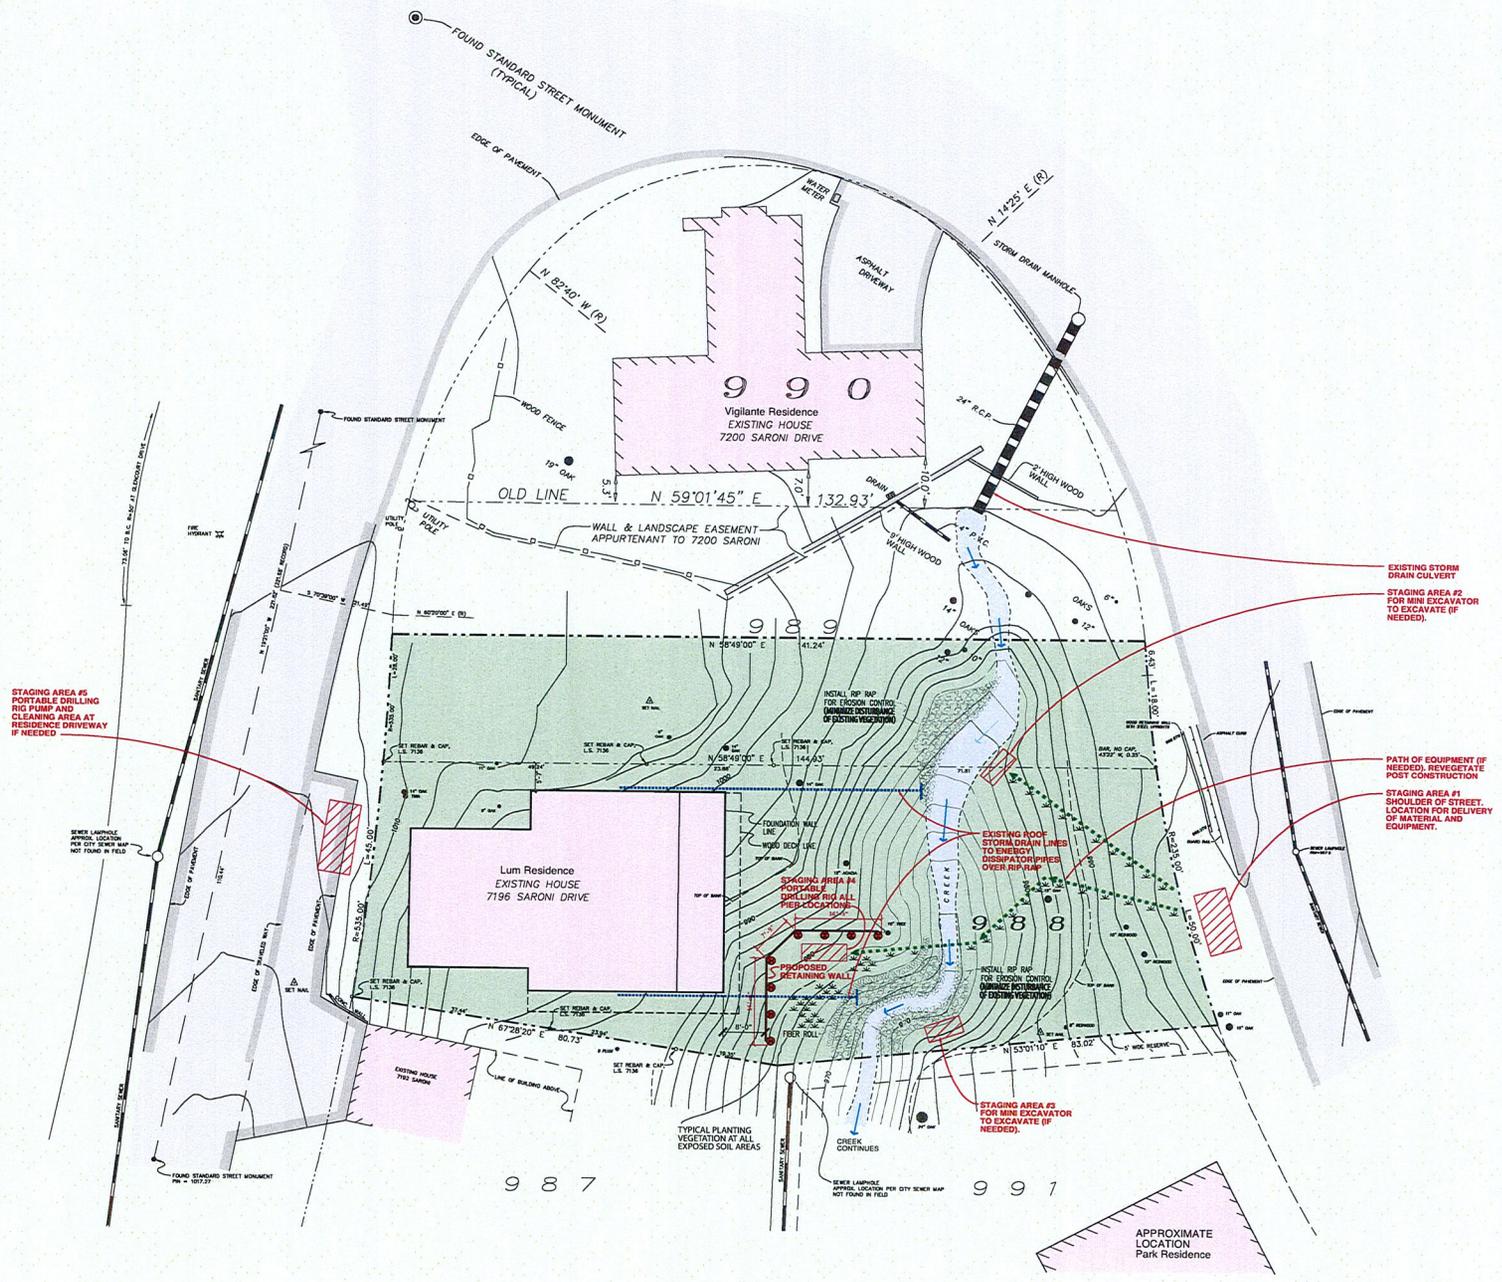
STAGING AREA #1 IS PORTABLE DRILLING RIG PUMP AND CLEANING AREA AT RESIDENCE DRIVEWAY IF NEEDED

EXISTING STORM DRAIN CULVERT
 STAGING AREA #2 FOR MINI EXCAVATOR TO EXCAVATE (IF NEEDED)

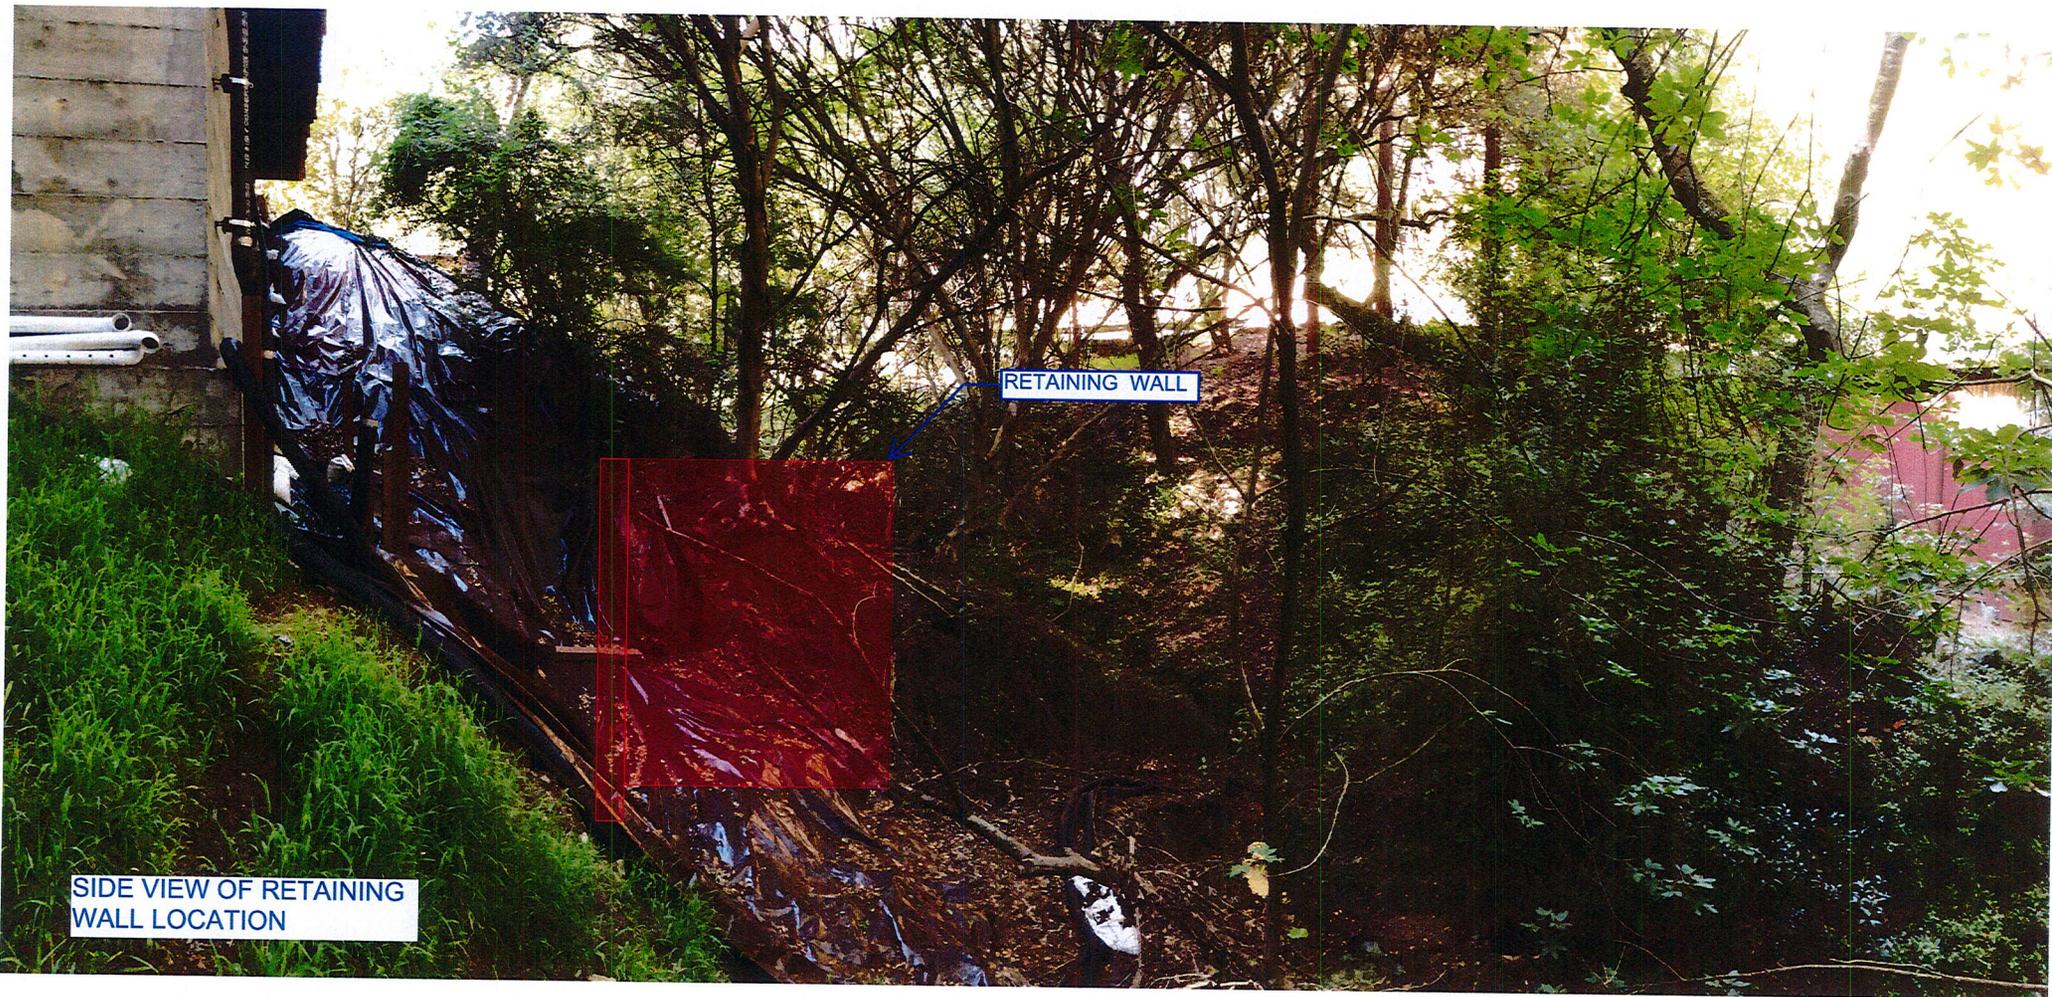
SIDE VIEW OF RETAINING
WALL LOCATION

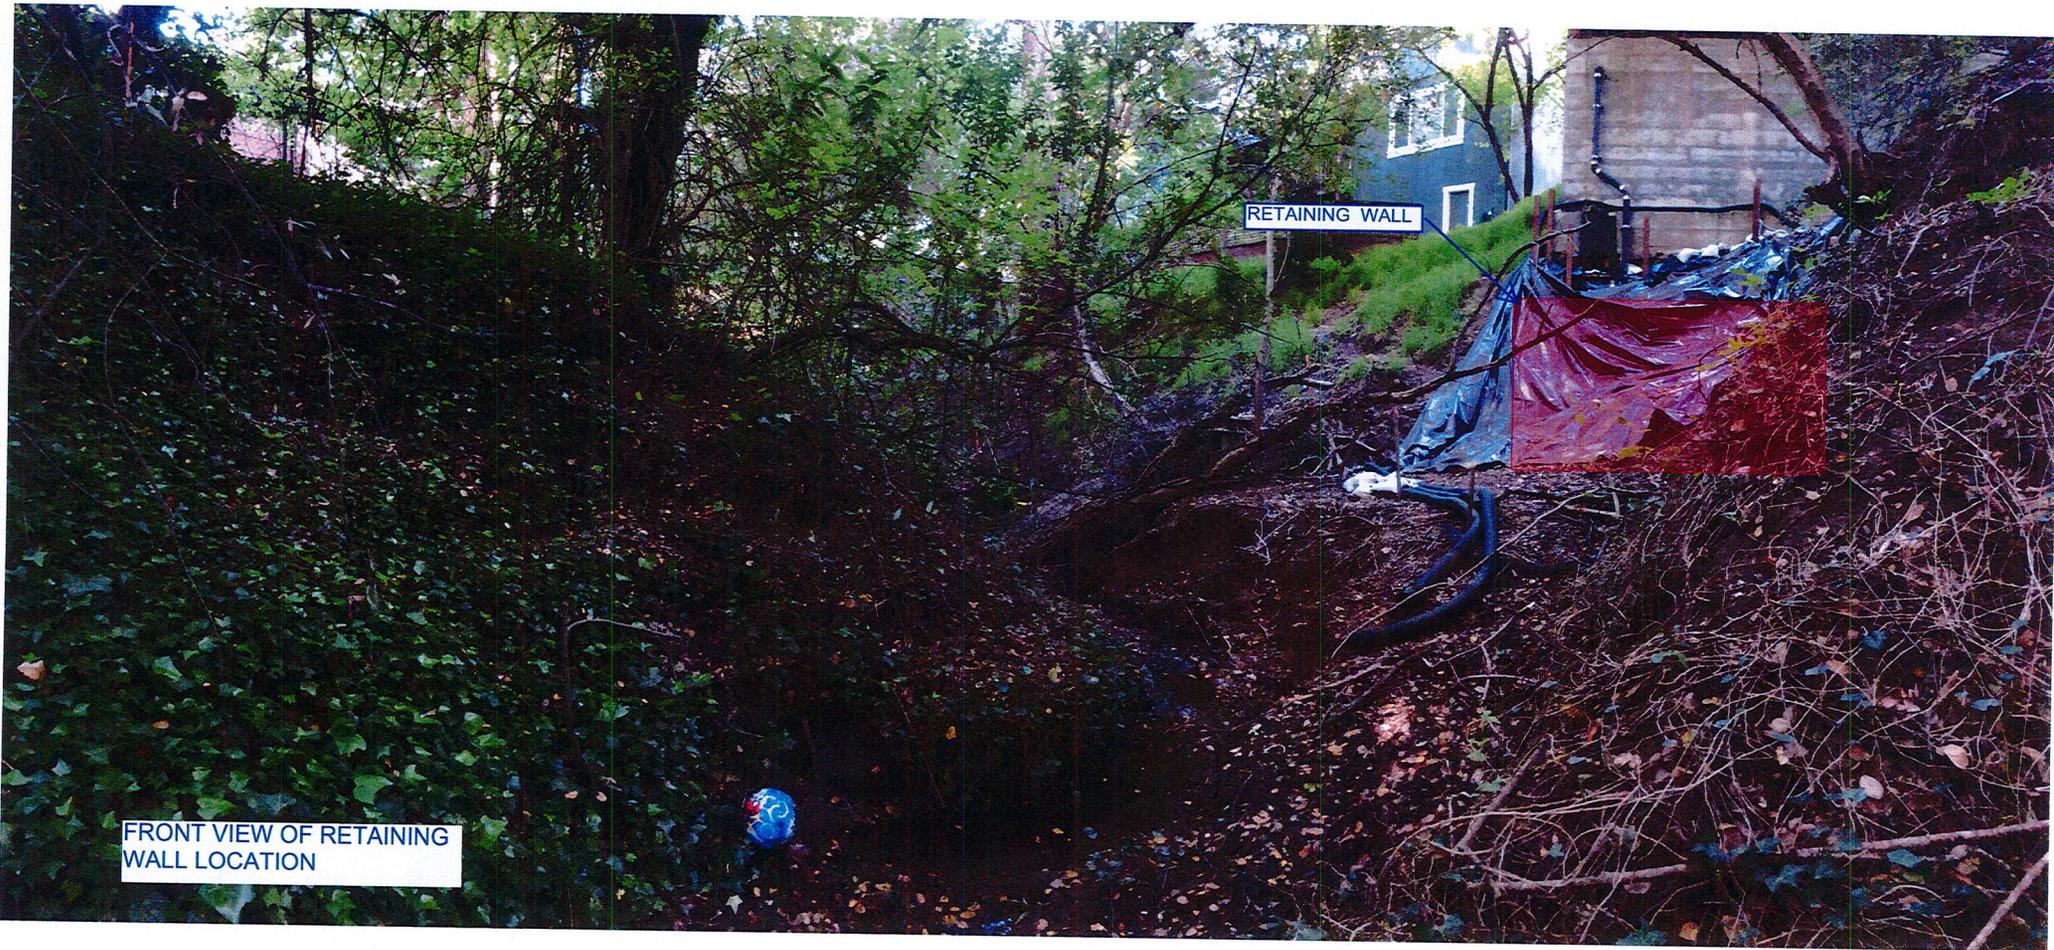
FRONT VIEW OF RETAINING WALL LOCATION
