WOOD DESTROYING PESTS AND ORGANISMS INSPECTION REPORT

BUILDING NO. 1214	STREET, CITY, STATE, ZIP 30TH STREET, OAKLAND CA 94608	Date of Inspection 10/24/2018	No. of Pages 10
EAST BAY STRUCTURAL & TERMITE CO. INC. 1096 Yerba Buena Avenue, Emeryville, CA 94608 Ph: (510) 652-4712 (510) 652-4790 Fax			
Firm Registration No. PR 4263	Report No. 182416	Escrow No.	
Ordered By: CITY OF OAKLAND RESIDENTIAL SVCS. 250 FRANK OGAWA PLAZA # 5313 OAKLAND, CA 94612 Attn: BRIANA MCGOWAN	Property Owner/Party of Interest c/o CITY OF OAKLAND RESIDENTIAL SVC	Report Sent To: CITY OF OAKLAND RESIDENTIAL SVCS. 250 FRANK OGAWA PLAZA # 5313 OAKLAND, CA 94612 Attn: ALI RAFIEETARI	
COMPLETE REPORT <input checked="" type="checkbox"/> LIMITED REPORT <input type="checkbox"/> SUPPLEMENTAL REPORT <input type="checkbox"/> REINSPECTION REPORT <input type="checkbox"/>			
General Description: TRIPLEX, COMPOSITE MATERIAL AND SHINGLE SIDING EXTERIOR, VACANT		Inspection Tag Posted: REAR RIGHT ROOM LOWER LEVEL.

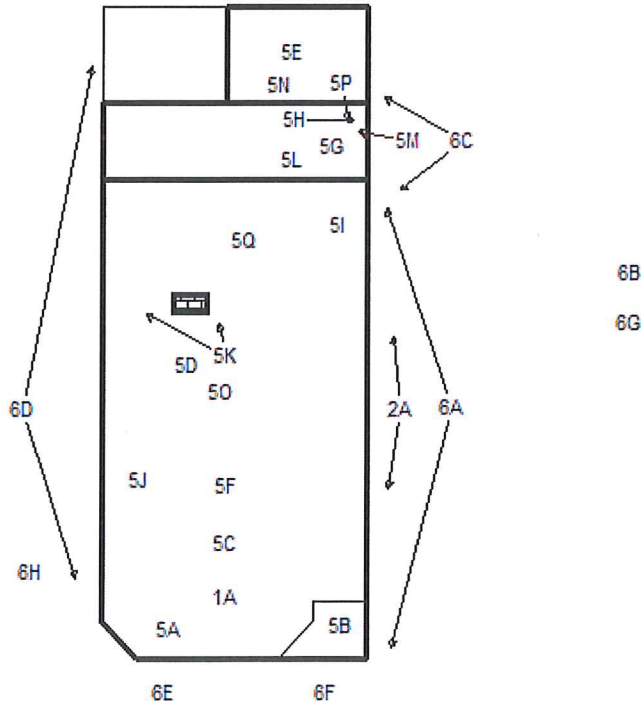
Other Tags Posted: NONE NOTED	
An inspection has been made to the structure(s) shown on the diagram in accordance with the Structural Pest Control Act. Detached porches, detached steps, detached decks and any other structures not on the diagram were not inspected.			
Subterranean Termites <input type="checkbox"/> Drywood Termites <input type="checkbox"/> Fungus/Dryrot <input checked="" type="checkbox"/> Other Findings <input checked="" type="checkbox"/> Further Inspection <input checked="" type="checkbox"/>			
If any of above boxes are checked, it indicates that there were visible problems in accessible areas. Read the report for details on checked items.
